PIC16F88X Family Silicon Errata and Data Sheet Clarification

The PIC16F88X family devices that you have received conform functionally to the current Device Data Sheet (DS41291G), except for the anomalies described in this document.

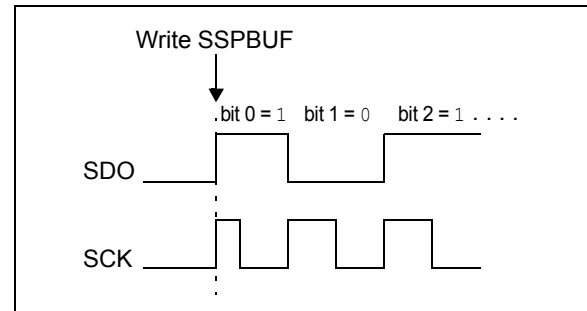
FIGURE 1: SCK PULSE VARIATION USING TIMER2/2

When the SPI is using Timer2/2 as the clock source, a shorter than expected SCK pulse may occur on the first bit of the transmitted/received data ([Figure 1](#)).

To avoid producing the short pulse, turn off Timer2 and clear the TMR2 register, load SSPBUF with the data to transmit and then turn Timer2 back on. Refer to [Example 1](#) for sample code.

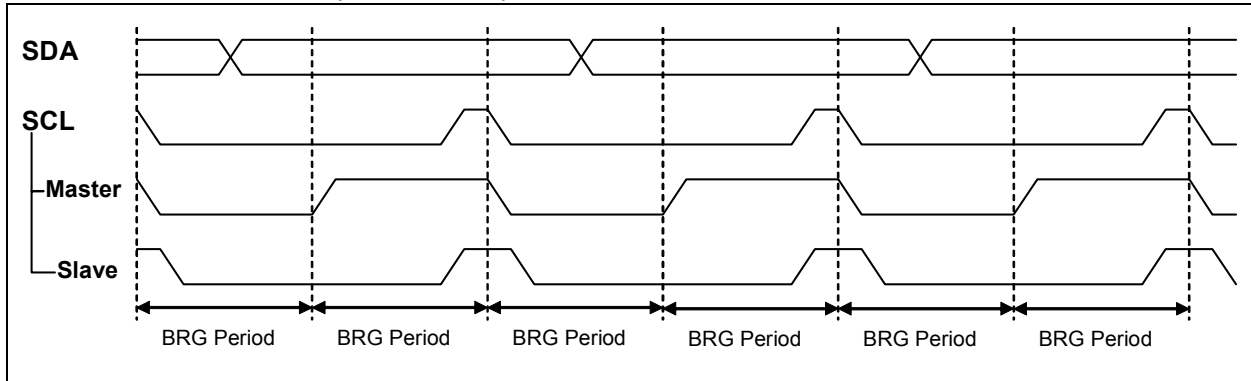
FIGURE 3: ACTUAL (INCORRECT) OPERATION WITH CLOCK STRETCHING – EXAMPLE 1

The current implementation does not ensure accurate SCL high time. During clock stretch, the MSSP device will erroneously continue running the BRG counter. At the end of the clock stretch, the BRG counter continues to count down for the

remainder of the BRG period, and then the MSSP device will immediately resume transmitting the data.

Figure 3 and Figure 4 illustrate an actual I²C transmission in which the slave has stretched the clock period by holding the SCL line low. Note that the high time of the SCL signal has shortened from the expected time.

Set the communication speed to match the slowest device on the bus. This ensures that no slave device will perform clock stretching.

It is possible to dynamically adjust the communication speed to match the device being addressed by modifying the BRG register. However, the behavior of slower slave devices must be understood and speed adjustments made such that no slave performs clock stretching.
