**TMS320VC5510**  
**Digital Signal Processor**  
**Silicon Errata**

SPRZ008K  
September 2001 – Revised May 2004

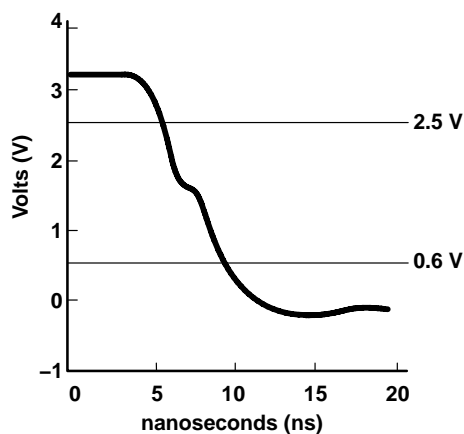
**Figure 3. Bad TCK Transition**

This phenomenon is observed when an erroneous clock edge is generated from the TCK signal inside the C55x™ DSP. This can be caused by several factors, acting independently or cumulatively:

- TCK transition times (as measured between 2.4 V and 0.8 V) in excess of 3 ns.
- Operating the C55x DSP in a socket, which can aggravate noise or glitches on the TCK input.
- Poor signal integrity on the TCK line from reflections or other layout issues.

A TCK edge that can cause this problem might look similar to the one shown in Figure 3. A TCK edge that does not cause the problem looks similar to the one shown in Figure 4. The key difference between the two figures is that Figure 4 has a clean and sharp transition whereas Figure 3 has a “knee” in the transition zone. Problematic TCK signals may not have a knee that is as pronounced as the one in Figure 3. Due to the TCK signal amplification inside the chip, any perturbation of the signal can create erroneous clock edges.

As the problem may be caused by one or more of the above factors, one or more of the steps outlined below may be necessary to fix it:

- Avoid using a socket
- Ensure the board design achieves rise times and fall times of less than 3 ns with clean monotonic edges for the TCK signal.
- For designs where TCK is supplied by the emulation pod, use a C55x Emulation Adapter Board, part number DSP8102U. To order a C55x Emulation Adapter Board, please contact the TI Product Information Center (PIC).

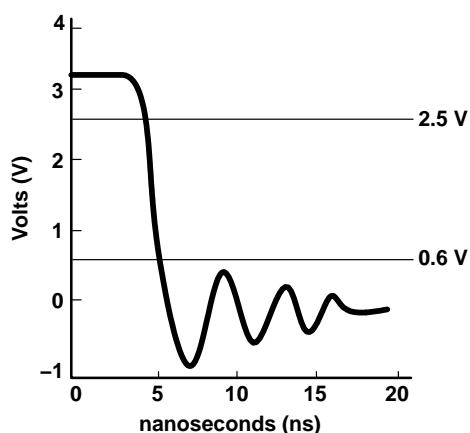
**Figure 4. Good TCK Transition****Workaround:**

As a result of the faster edge transition, there is increased ringing in Figure 4. As long as the ringing does not cross logic input thresholds (0.8 V for falling edges, and 2.4 V for rising edges), this ringing is acceptable.
