This errata sheet provides information about known device issues affecting Arria® V production devices.

## Device Errata for Arria V Production Devices

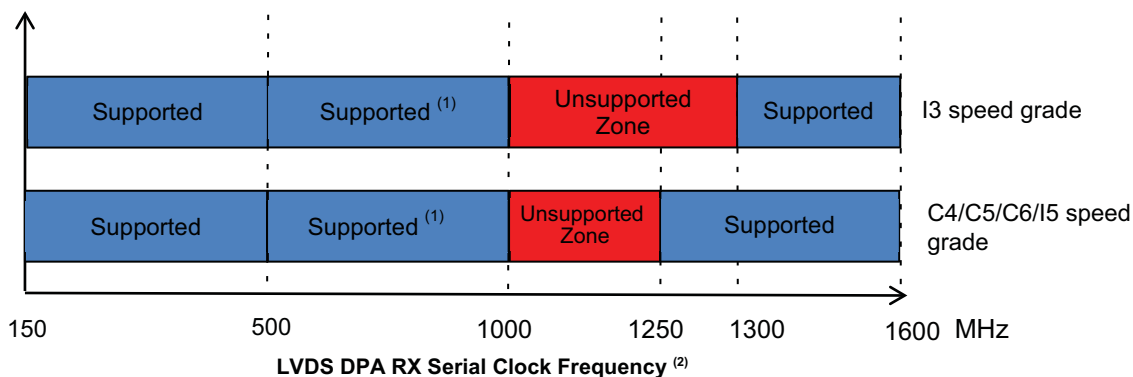
**Figure 1. Arria V GX/GT LVDS DPA RX Supported and Unsupported Data Rates**

DPA mode or soft-CDR mode is not supported for specific LVDS data rate as shown in [Figure 1](#). If the RX channels with DPA are operating in the unsupported zone, bit errors may occur. This limited LVDS data rate support impacts early die revision Arria V GX/GT device when LVDS receiver channels operating in DPA mode or soft-CDR mode. LVDS receiver channels operating in non-DPA are not affected. The unsupported data rate zones are dependent on device speed grade as shown in [Figure 1](#). The affected Arria V GX/GT die revisions are shown in [Table 6](#).

- (1) Supported with recompilation in Quartus II version 13.0 and later. Not supported in Quartus II version 12.1SP1 and earlier. If the RX channels with DPA are operating in this zone with Quartus II version 12.1SP1 and earlier, bit errors may occur.
- (2) The scale of the LVDS DPA RX serial clock frequency is for illustration purposes only.

For the LVDS data rate solutions in the unsupported zones, refer to [Table 4](#) and [Table 5](#).

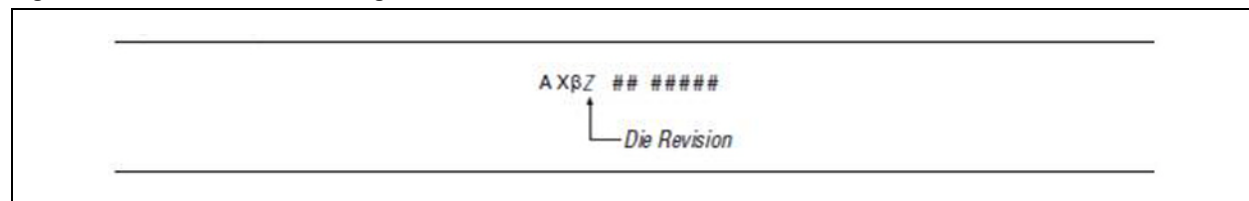
**Figure 2. Altera Date Code Marking Format**

Member code	Revisions without Fix	Revision with Fix <sup>(1)</sup>
5AGTD7	A, B	C
<b>Note to Table 6:</b> (1) Refer to Figure 2 for the Arria V device's top side data code. This issue is fixed if the fourth alphanumeric character (Z) from the left printed on the top side of the device is equal to or later in the alphabet than the letter shown in the Revision with Fix column.

CvP update can only be used at Gen1 data rates. CvP is supported if the fourth alphanumeric character (Z) from the left printed on the top side of the device is equal to or later in the alphabet than the letter shown in the Revision with Fix column of Table 8.
