This errata sheet provides information about known issues affecting Cyclone® V devices.

Table 1 lists the specific device issues and the affected Cyclone V devices.

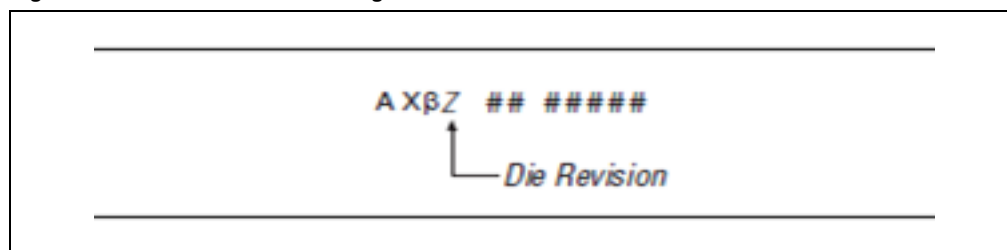
**Figure 1. Altera Date Code Marking Format**

The fix for this issue requires a new die revision. Use the die revision character in the Date Code (printed on the top side of the device) to determine if the device supports CvP. The CvP update can only be used at Gen1 data rates.

CvP is supported if the fourth alphanumeric character from the left ("Z" in Figure 1) is equal to, or later in the alphabet than the letter in the **Revision with Fix** column of Table 4: Device and Die Revisions.
