MSP430BT5190 Device Erratasheet

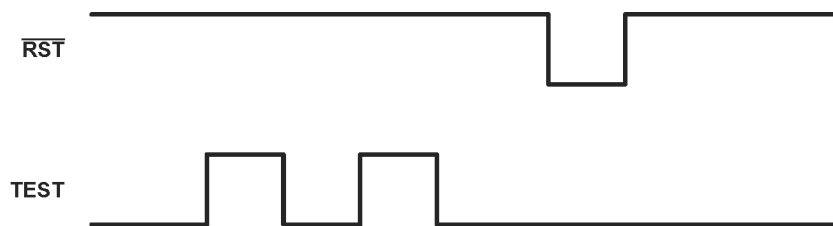
Note: This sequence is not subject to timing constraints and the appropriate level transitions are sufficient to trigger an exit from BSL mode.

- Toggle the TEST pin twice when nRST is high and then pull nRST low.
