## **MSP430F149 Device Erratasheet**

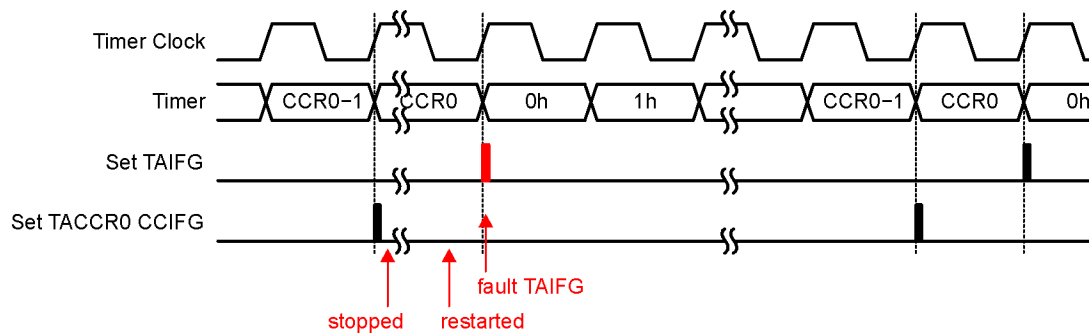
**TA21**
***TIMER\_A Module***
**Function**

TAIFG Flag is erroneously set after Timer A restarts in Up Mode

In Up Mode, the TAIFG flag should only be set when the timer resets from TACCR0 to zero. However, if the Timer A is stopped at TAR = TACCR0, then cleared (TAR=0) by setting the TACLRL bit, and finally restarted in Up Mode, the next rising edge of the TACLRL will erroneously set the TAIFG flag.

None.

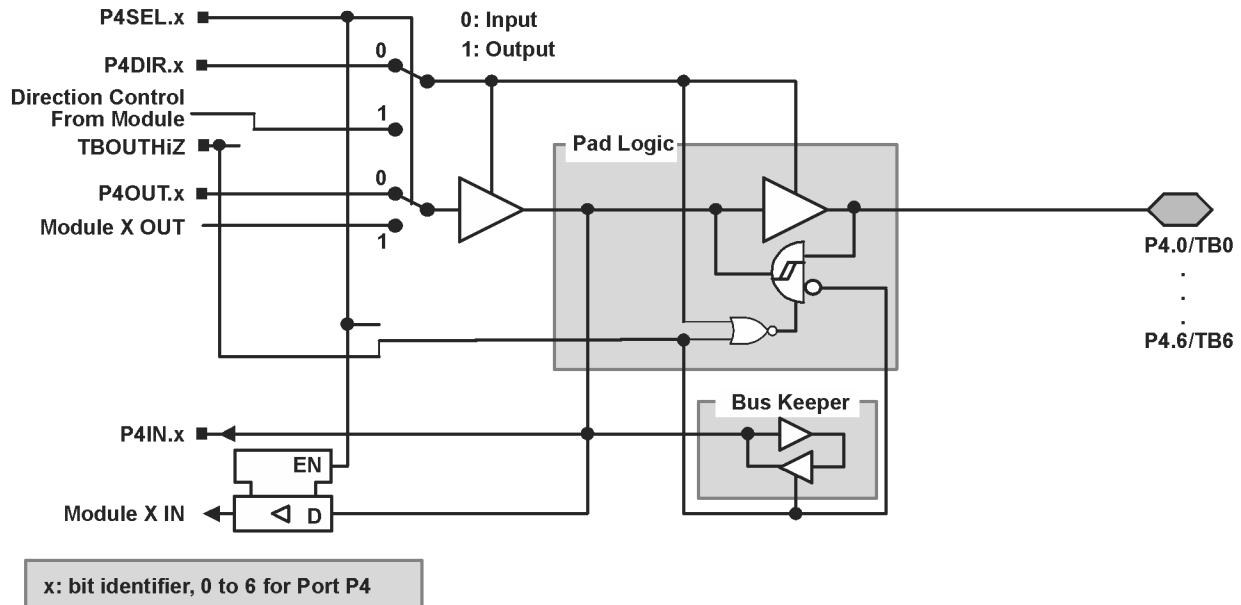
Port Realization With TB3 Bug

Port is switched to 3-state independent of selected function

Incorrect 3-state function of Ports P4.0/TB0 through P4.6/TB6 (TBoutHiZ control). If TBoutHiZ is set to high, all ports P4.0/TB0 through P4.6/TB6 are set to 3-state, independent of the P4SEL.x control signals. This means a port P4.x is switched to 3-state with TBoutHiZ, even if it is not selected for Timer\_B function. In addition, the ports P4.0/TB0 through P4.6/TB6 are switched to 3-state with TBoutHiZ, even if the port direction (direction control from module) is set to input. This is in accordance with the specification description but, nevertheless, is an unexpected behavior.

No workaround.

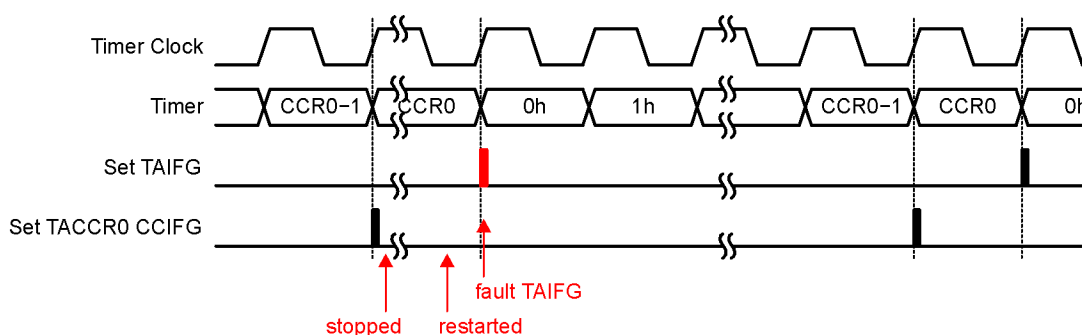
## TB24 *TIMER\_B Module*

**Function** TBIFG Flag is erroneously set after Timer B restarts in Up Mode

**Description** In Up Mode, the TBIFG flag should only be set when the timer resets from TBCCR0 to zero. However, if the Timer A is stopped at TBR = TBCCR0, then cleared (TBR=0) by setting the TBCLR bit, and finally restarted in Up Mode, the next rising edge of the TBCLK will erroneously set the TBIFG flag.

**Workaround** None.
