## **MSP430F157 Device Erratasheet**

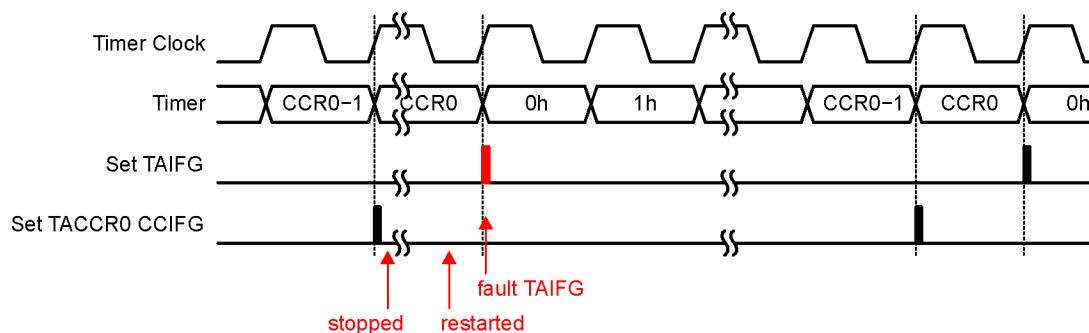
## TA21

<b>Function</b>	TAIFG Flag is erroneously set after Timer A restarts in Up Mode
<b>Description</b>	In Up Mode, the TAIFG flag should only be set when the timer resets from TACCR0 to zero. However, if the Timer A is stopped at TAR = TACCR0, then cleared (TAR=0) by setting the TACLR bit, and finally restarted in Up Mode, the next rising edge of the TACLK will erroneously set the TAIFG flag.

<b>Workaround</b>	None.
-------------------	-------

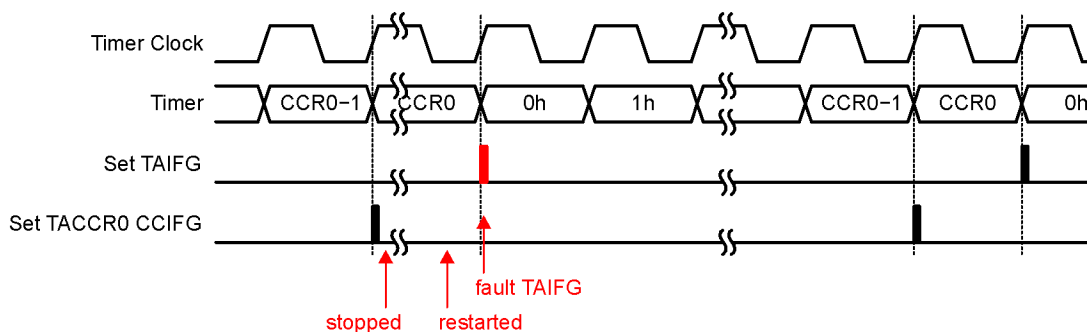
**TB24**
**TIMER\_B Module**
**Function**

TBIFG Flag is erroneously set after Timer B restarts in Up Mode

In Up Mode, the TBIFG flag should only be set when the timer resets from TBCCR0 to zero. However, if the Timer A is stopped at  $TBR = TBCCR0$ , then cleared ( $TBR=0$ ) by setting the TBCLR bit, and finally restarted in Up Mode, the next rising edge of the TBCLK will erroneously set the TBIFG flag.

None.
