MSP430F247 Device Erratasheet

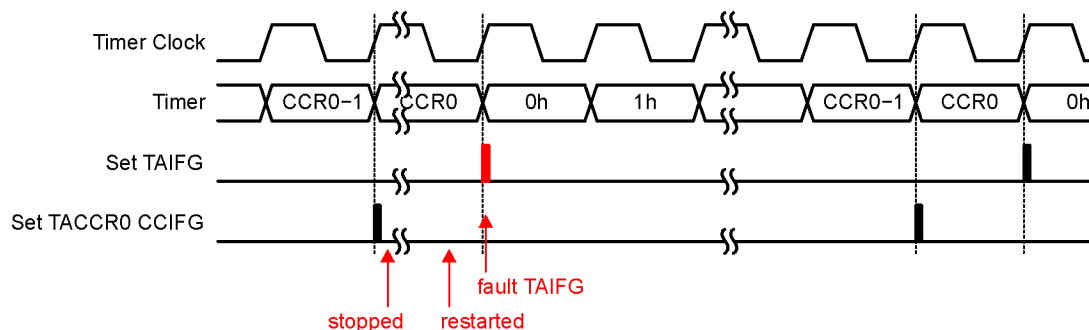
TA21 *TIMER_A Module*

Function TAIFG Flag is erroneously set after Timer A restarts in Up Mode

Description In Up Mode, the TAIFG flag should only be set when the timer resets from TACCR0 to zero. However, if the Timer A is stopped at TAR = TACCR0, then cleared (TAR=0) by setting the TACLR bit, and finally restarted in Up Mode, the next rising edge of the TACLK will erroneously set the TAIFG flag.

Workaround None.
