MSP430F4152 Device Erratasheet

3 Detailed Bug Description

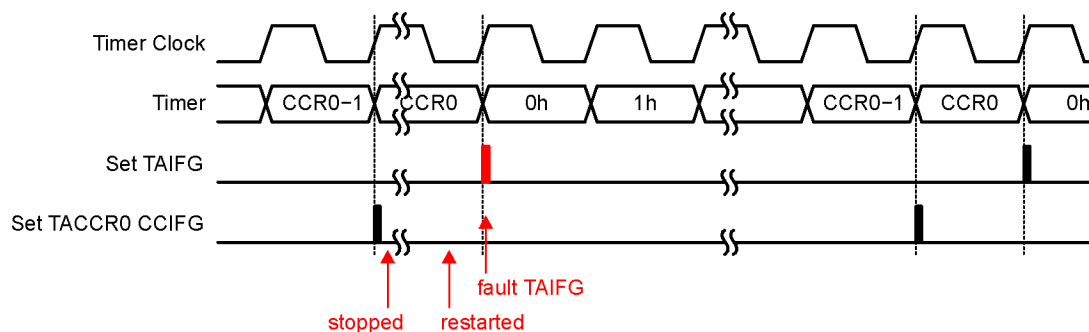
TA21

TAIFG Flag is erroneously set after Timer A restarts in Up Mode

In Up Mode, the TAIFG flag should only be set when the timer resets from TACCR0 to zero. However, if the Timer A is stopped at TAR = TACCR0, then cleared (TAR=0) by setting the TACLR bit, and finally restarted in Up Mode, the next rising edge of the TACLK will erroneously set the TAIFG flag.

None.
