## MSP430F5324 Device Erratasheet

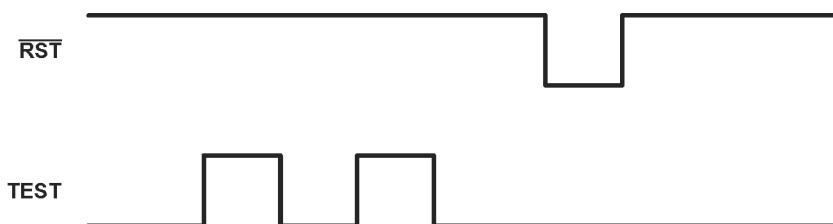
- Toggle the TEST pin twice when nRST is high and then pull nRST low.

Note: This sequence is not subject to timing constraints and the appropriate level transitions are sufficient to trigger an exit from BSL mode.
