MSP430F5325 Device Erratasheet

1 Revision History

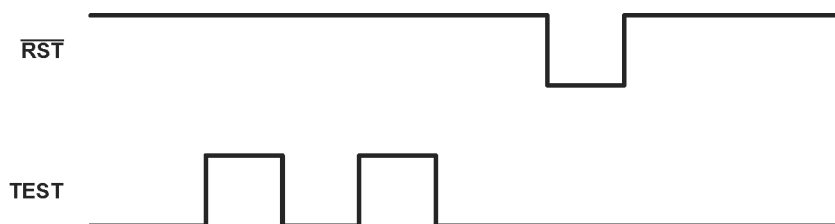
BSL does not exit to application code

The methods used to exit the BSL per MSP430 Programming Via the Bootstrap Loader ([SLAU319](#)) are invalid.

To exit the BSL one of the following methods must be used.

- A Power cycle

- Toggle the TEST pin twice when nRST is high and then pull nRST low.

Note: This sequence is not subject to timing constraints and the appropriate level transitions are sufficient to trigger an exit from BSL mode.
