MSP430F5326 Device Erratasheet

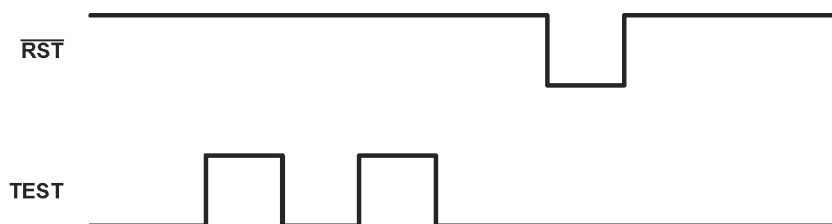
or

- Toggle the TEST pin twice when nRST is high and then pull nRST low.

Note: This sequence is not subject to timing constraints and the appropriate level transitions are sufficient to trigger an exit from BSL mode.
