MSP430F5327 Device Erratasheet

1 Revision History

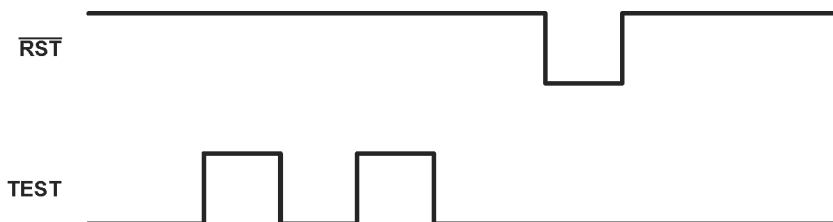
- Toggle the TEST pin twice when nRST is high and then pull nRST low.

Note: This sequence is not subject to timing constraints and the appropriate level transitions are sufficient to trigger an exit from BSL mode.
