MSP430F5329 Device Erratasheet

4 Detailed Bug Description

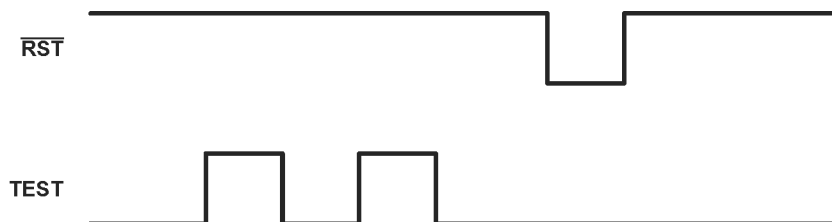
JTAG20
JTAG Module
Function

BSL does not exit to application code

The methods used to exit the BSL per MSP430 Programming Via the Bootstrap Loader ([SLAU319](#)) are invalid.

To exit the BSL one of the following methods must be used.

- A Power cycle

- Toggle the TEST pin twice when nRST is high and then pull nRST low.

Note: This sequence is not subject to timing constraints and the appropriate level transitions are sufficient to trigger an exit from BSL mode.
