MSP430F5333 Device Erratasheet

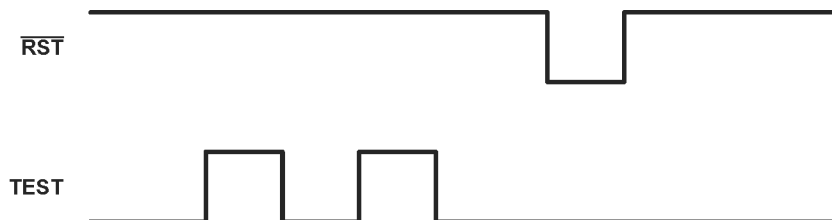
JTAG20 *JTAG Module*

Function BSL does not exit to application code

Description The methods used to exit the BSL per MSP430 Programming Via the Bootstrap Loader ([SLAU319](#)) are invalid.

Workaround To exit the BSL one of the following methods must be used.

- A Power cycle

or

- Toggle the TEST pin twice when nRST is high and then pull nRST low.

Note: This sequence is not subject to timing constraints and the appropriate level transitions are sufficient to trigger an exit from BSL mode.
