MSP430F5436A Device Erratasheet

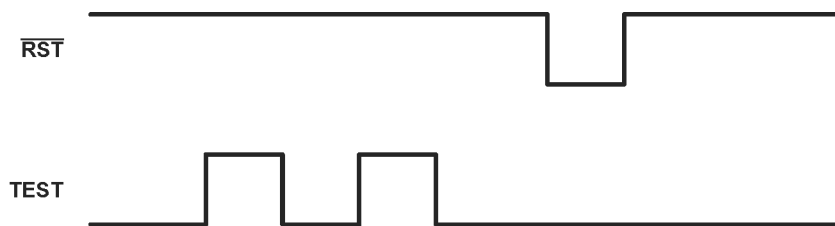
or

- Toggle the TEST pin twice when nRST is high and then pull nRST low.

Note: This sequence is not subject to timing constraints and the appropriate level transitions are sufficient to trigger an exit from BSL mode.
