MSP430F5438A Device Erratasheet

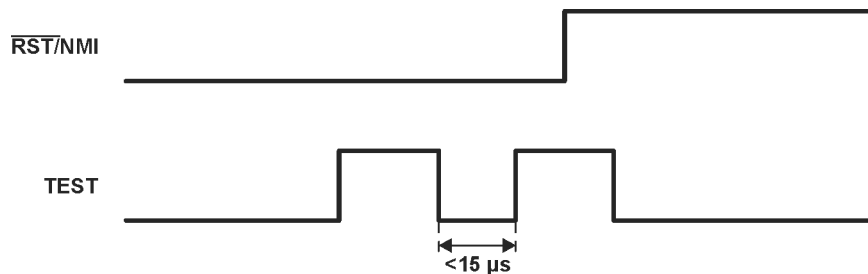
The BSL entry sequence requires that the low phase of the TEST/SBWTCK pin does not exceed 15us. This timing requirement is faster than most PC serial ports can provide, as shown in the following picture. If this requirement is not met, the entry sequence fails and the SYSBSLIND is not set.

An external hardware solution is recommended to provide the appropriate BSL entry sequence. See [http://processors.wiki.ti.com/index.php/BSL_\(MSP430\)](http://processors.wiki.ti.com/index.php/BSL_(MSP430)) for recommendations on available BSL hardware.
