MSP430F5510 Device Erratasheet

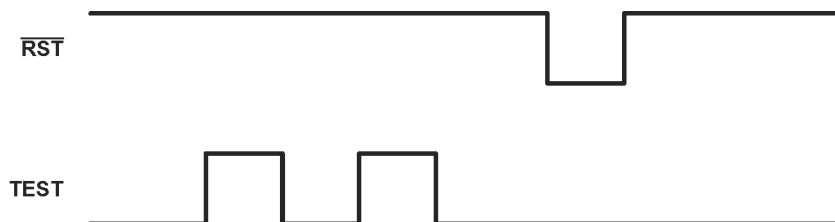
JTAG20

BSL does not exit to application code

The methods used to exit the BSL per MSP430 Programming Via the Bootstrap Loader ([SLAU319](#)) are invalid.

To exit the BSL one of the following methods must be used.

- A Power cycle

- Toggle the TEST pin twice when nRST is high and then pull nRST low.

Note: This sequence is not subject to timing constraints and the appropriate level transitions are sufficient to trigger an exit from BSL mode.
