MSP430F5528 Device Erratasheet

1 Revision History

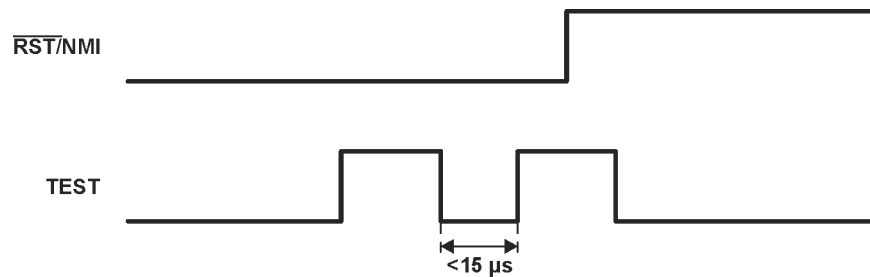
The BSL entry sequence requires that the low phase of the TEST/SBWTC pin does not exceed 15us. This timing requirement is faster than most PC serial ports can provide, as shown in the following picture. If this requirement is not met, the entry sequence fails and the SYSBSLIND is not set.

An external hardware solution is recommended to provide the appropriate BSL entry sequence. See [http://processors.wiki.ti.com/index.php/BSL_\(MSP430\)](http://processors.wiki.ti.com/index.php/BSL_(MSP430)) for recommendations on available BSL hardware.
