## MSP430F5631 Device Erratasheet

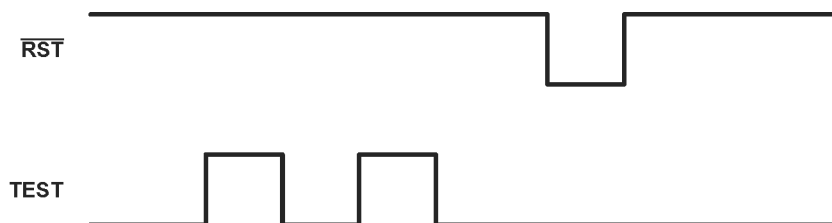
BSL does not exit to application code

The methods used to exit the BSL per MSP430 Programming Via the Bootstrap Loader ([SLAU319](#)) are invalid.

To exit the BSL one of the following methods must be used.

- A Power cycle

- Toggle the TEST pin twice when nRST is high and then pull nRST low.

Note: This sequence is not subject to timing constraints and the appropriate level transitions are sufficient to trigger an exit from BSL mode.
