## MSP430F5634 Device Erratasheet

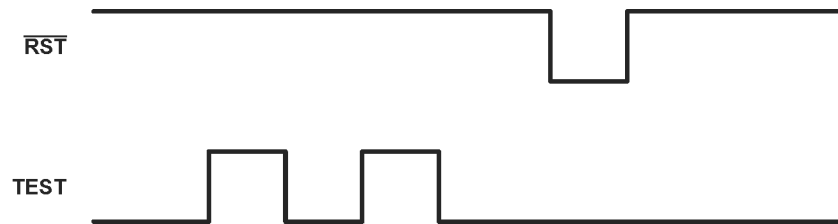
BSL does not exit to application code

The methods used to exit the BSL per MSP430 Programming Via the Bootstrap Loader ([SLAU319](#)) are invalid.

To exit the BSL one of the following methods must be used.

- A Power cycle

- Toggle the TEST pin twice when nRST is high and then pull nRST low.

Note: This sequence is not subject to timing constraints and the appropriate level transitions are sufficient to trigger an exit from BSL mode.
