MSP430F5637 Device Erratasheet

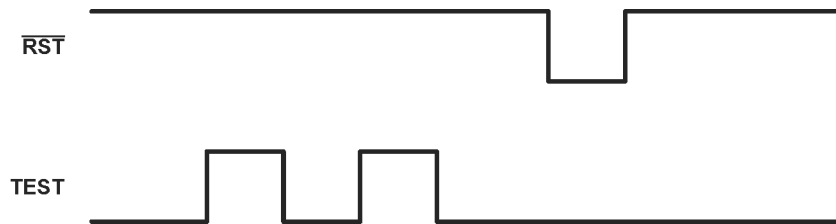
JTAG20
JTAG Module

BSL does not exit to application code

The methods used to exit the BSL per MSP430 Programming Via the Bootstrap Loader ([SLAU319](#)) are invalid.

To exit the BSL one of the following methods must be used.

- A Power cycle

- Toggle the TEST pin twice when nRST is high and then pull nRST low.

Note: This sequence is not subject to timing constraints and the appropriate level transitions are sufficient to trigger an exit from BSL mode.
