Stellaris® LM3S9B90 RevB1 Errata

This document contains known errata at the time of publication for the Stellaris LM3S9B90 microcontroller. The table below summarizes the errata and lists the affected revisions. See the data sheet for more details.

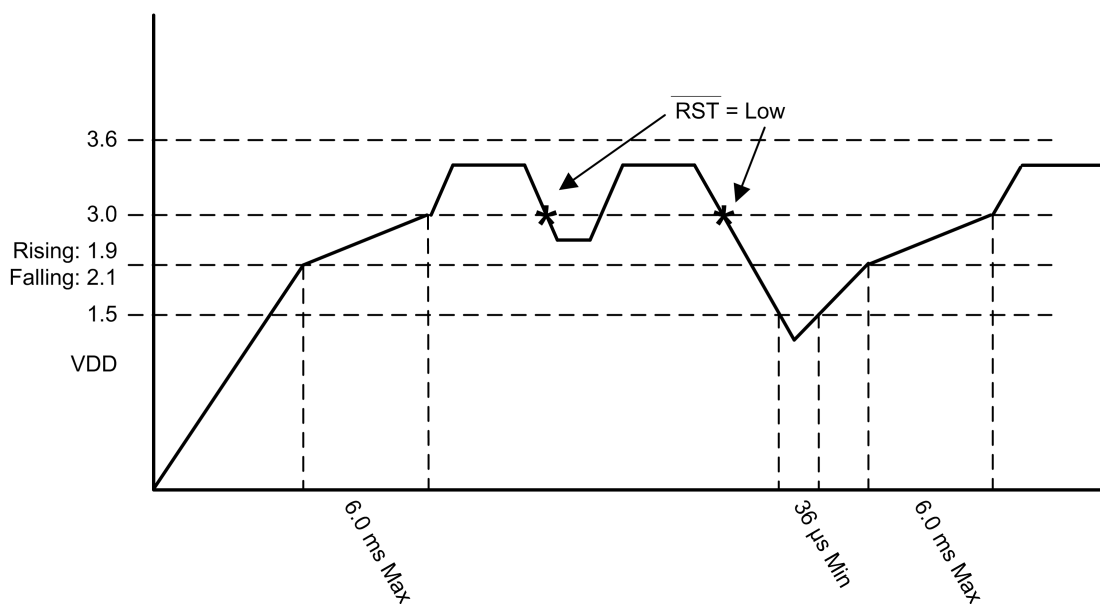
Figure 1. VDD Waveform Signature Limits

Depending on the system environment requirement, items 3, 4, and 5 in the above list may be met by using a voltage supervisor, such as the TLV803M, to monitor a higher voltage rail from which the VDD supply is regulated. Figure 2 on page 15 shows this implementation with a voltage supervisor monitoring the 5-V rail and a voltage trip point of 4.38 V. A voltage supervisor with a lower voltage trip point can be used to monitor the VDD (3.3-V) rail, however this supervisor must assert reset before VDD reaches 3.0 V. Regardless of the implemented voltage supervisor circuit, the system designer must ensure that there is enough time to assert $\overline{\text{RST}}$ Low prior to VDD falling below 3.0 V. Figure 3 on page 15 shows the resulting waveform of the circuit shown in Figure 2 on page 15.

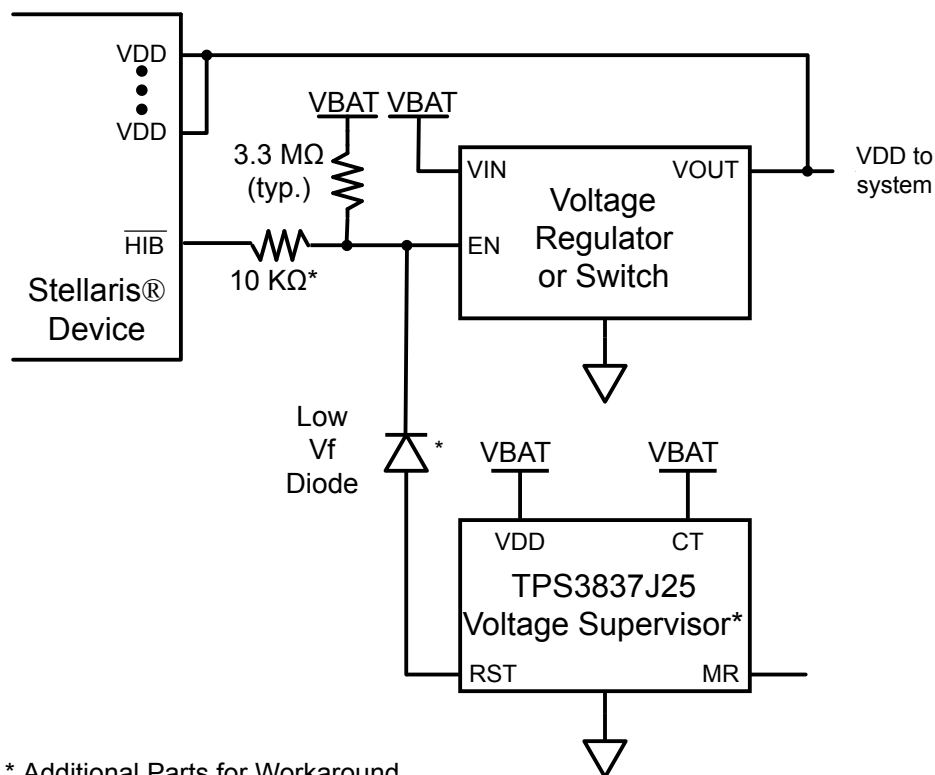
Figure 5. Workaround Circuit to Ensure Initial Power Up

If V_{DD} is not powered when voltage is first applied to V_{BAT} , the state of the Hibernation module is indeterminate and the \overline{HIB} signal may be asserted. In this indeterminate state, a lock condition can occur in which the Hibernation module waits for a power-on-reset, but that reset cannot occur until the module deasserts \overline{HIB} . This issue is related to the errata "Hibernation module may have higher current draw than specified in data sheet under certain conditions" on page 17.

The workaround implementation depends on the system-level power supply configuration. For systems that use a battery as the primary power source, an external voltage supervisor (TPS383J25DBV or similar) circuit can be added to force the V_{DD} power supply to start when the battery voltage is first applied (see Figure 5). The voltage supervisor requires only 220 nA and generates a 200-ms positive pulse to turn on the V_{DD} regulator and activate the microcontroller's internal POR circuit.

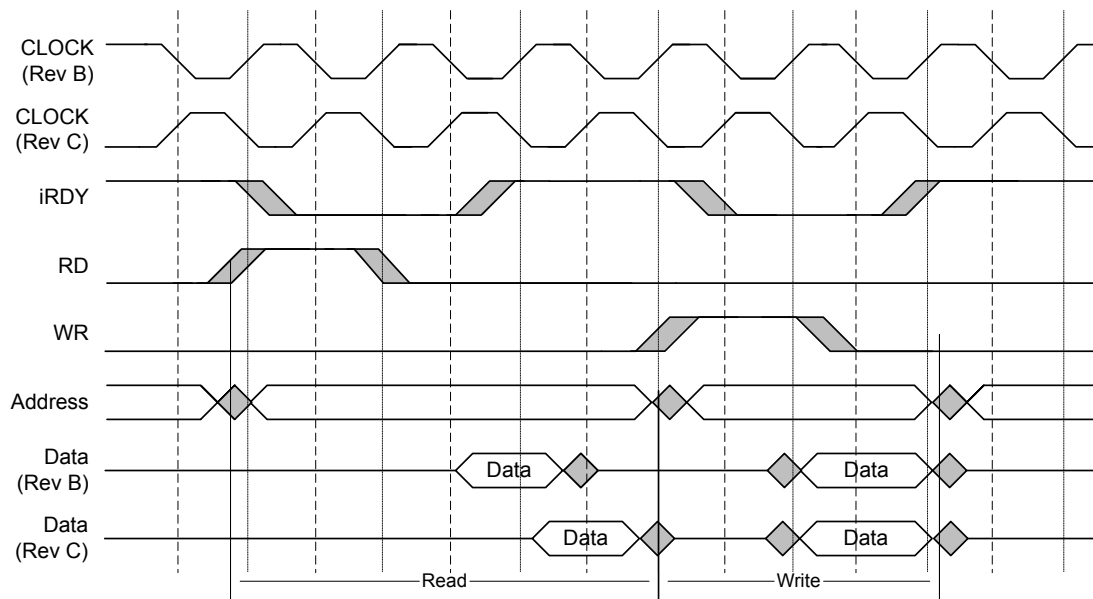
Figure 6. Timing Differences Between Rev B and Rev C Devices

The clock signal that is output on the EPI0S31 signal in General-Purpose mode is inverted. Figure 6 on page 31 shows the timing differences between Rev B parts and Rev C parts.

Use the opposite edge for timing when designing with this interface. During read cycles, ensure that the data meets set up and hold times for the appropriate edge as shown in the diagram above.

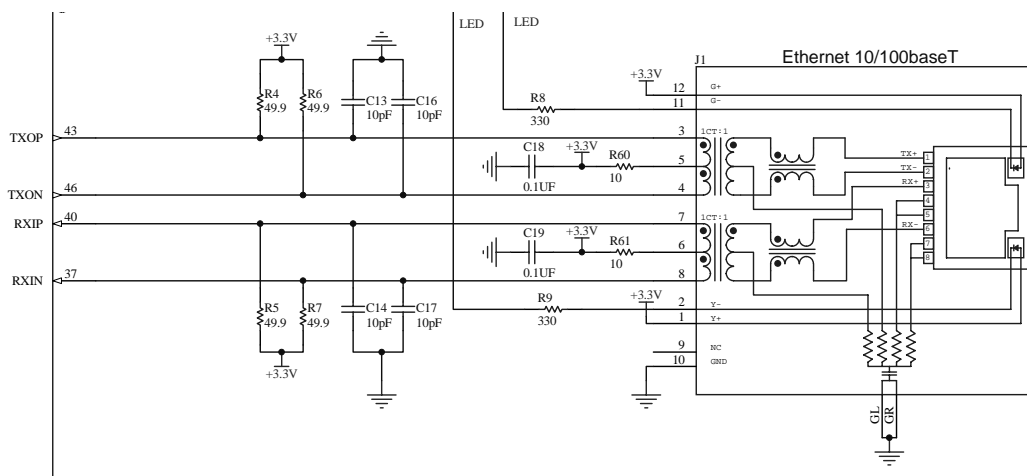
Figure 8. Recommended Center-Tap Connections

The microcontroller experiences some packet loss with Ethernet cables longer than 50 meters in normal operating conditions.

1. Add 10 Ω resistor to the center-tap of the transformer as shown in the figure. These resistors should be replaced by a direct connection for silicon that has this item fixed.
2. Continue using the recommended circuit, but limit cable lengths to 50 meters.

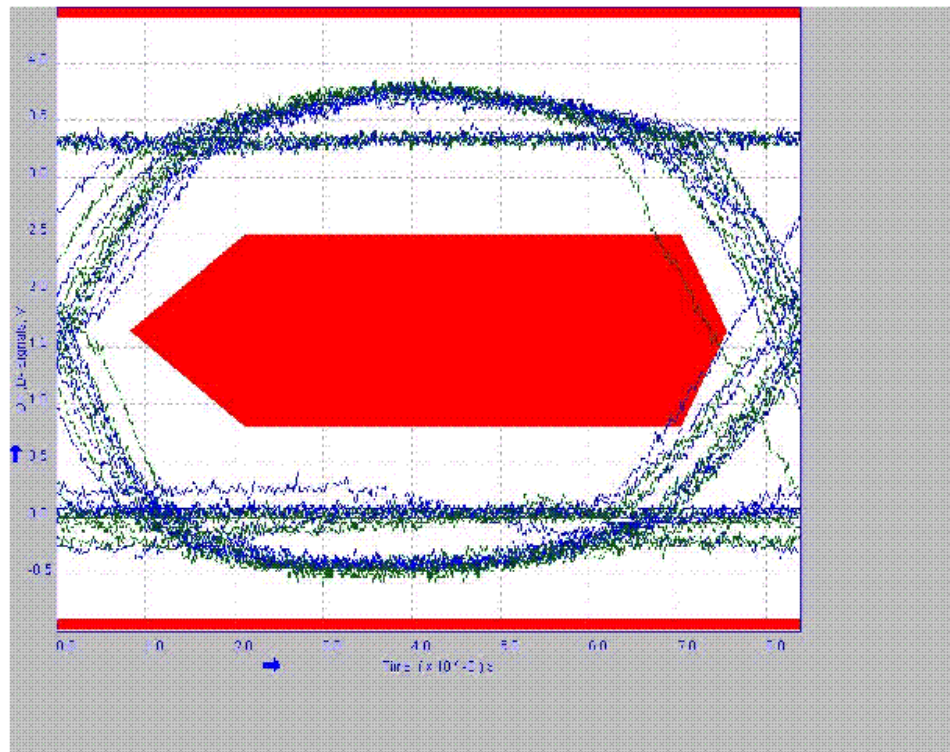
Figure 9. Example of USB Certification Failure

If the EPI module is operating, the USB interface may fail USB certification. Failures have been seen for the eye diagram and jitter (see Figure 9 on page 54). Because of these issues, there is a potential for data corruption on the USB interface when using the USB and EPI at the same time. The risk of data corruption is small, but is dependent on the system design.

- Signal eye:
Eye Diagram Test fails

- EOP width: 169.0995ns
EOP width passes
- Receivers: reliable operation on tier Tier 6
Receivers pass
- Measured Signalling Rate: 11.92707Mbps
signal rate conditionally passes
- Crossover voltage range: 1.546667 V to 1.680000 V
Mean crossover = 1.615889 V
First crossover at 1.660000 V(11 other differential crossovers checked)
crossover voltages pass
- Consecutive jitter range: -165.1885ns to 1.811468ns, RMS jitter 52.27256ns
Paired JK jitter range: 752.3810ps to 2.871429ns, RMS jitter 1.821542ns
Paired KJ jitter range: 1.185714ns to 2.168571ns, RMS jitter 1.695397ns
jitter fails

USB certification can be attained if an application does not require the USB and the EPI to be operating simultaneously. Customers who do not intend to pursue USB certification should determine if their application can handle the resulting small amount of error.

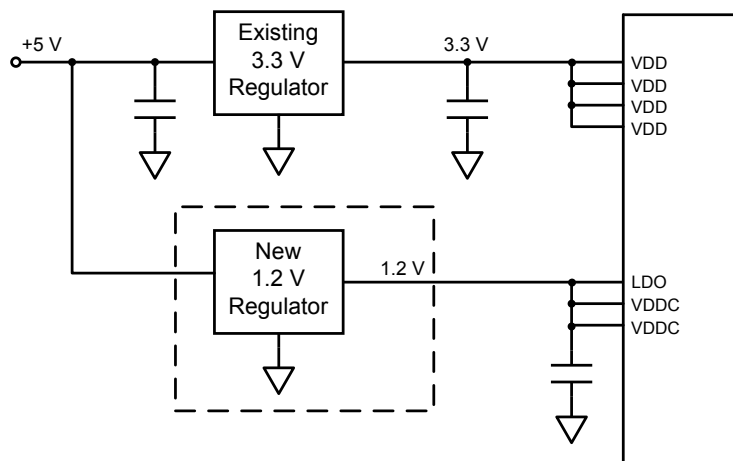
Figure 14. Configuration of External Regulator

Incorrect power sequencing during power up can disrupt operation and potentially cause device failure.

V_{DDC} must be applied approximately 50 μ s before V_{DD} . Normally V_{DDC} is controlled by the part's internal LDO voltage regulator. The workaround requires the addition of an external regulator (see Figure 14) to ensure that V_{DDC} sequencing requirements are met (see Figure 15). A recommended regulator is the TI TPS73101DBVR.

This fix mitigates the on-chip power issue, but does not solve it completely. During development, the Flash memory should also be reprogrammed (using LMFlash or another programming tool) at least once a week.
