## Stellaris® LM3S5732 RevA0 Errata

This document contains known errata at the time of publication for the Stellaris LM3S5732 microcontroller. The table below summarizes the errata and lists the affected revisions. See the data sheet for more details.

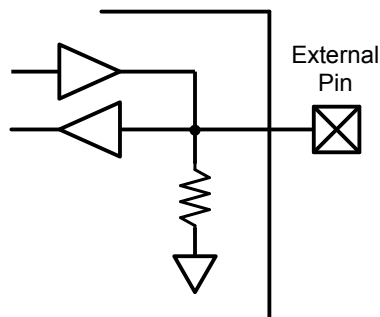
**Figure 1. Internal Structure of PB0 and PB1**

Regardless of their configuration, PB0 and PB1 have an internal pull-down resistance. The internal structure of these pins is shown in Figure 1 on page 12.

When either of these pins is configured as an input, the external circuit must provide enough drive strength to over-drive the internal pull-down and achieve the necessary  $V_{IH}$  voltage level. If an external pull-up resistor is used, it must have a low value such as  $\sim 1\text{ K}\Omega$  or less for PB0 and  $\sim 50\text{ K}\Omega$  or less for PB1.

When either of these pins is configured as an output, the drive current needed to over-drive the internal pull-down resistance must be subtracted from the drive capabilities of the pin. In some applications, it may be necessary to select a higher drive strength (such as 4 mA instead of 2 mA) to achieve an acceptable output voltage on PB0.
