Stellaris[®] LM3S9L71 RevC3 Errata

This document contains known errata at the time of publication for the Stellaris LM3S9L71 microcontroller. The table below summarizes the errata and lists the affected revisions. See the data sheet for more details.

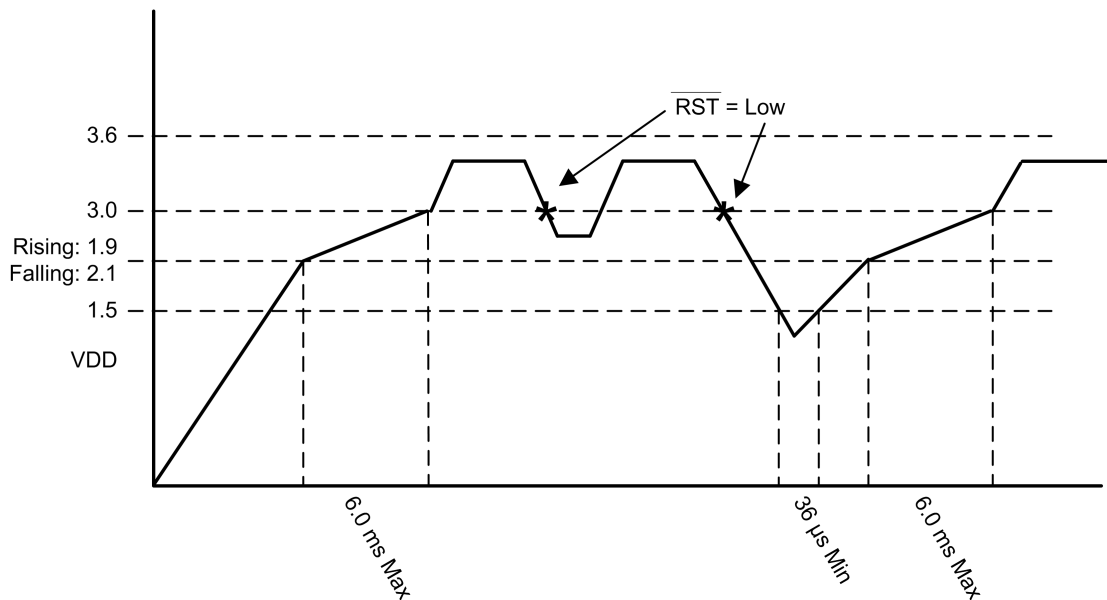
Figure 1. VDD Waveform Signature Limits

5. The **Brown-Out Reset Control (PBORCTL)** register must be set so that a brown-out event causes a reset.

Depending on the system environment requirement, items 3, 4, and 5 in the above list may be met by using a voltage supervisor, such as the TLV803M, to monitor a higher voltage rail from which the VDD supply is regulated. Figure 2 on page 16 shows this implementation with a voltage supervisor monitoring the 5-V rail and a voltage trip point of 4.38 V. A voltage supervisor with a lower voltage trip point can be used to monitor the VDD (3.3-V) rail, however this supervisor must assert reset before VDD reaches 3.0 V. Regardless of the implemented voltage supervisor circuit, the system designer must ensure that there is enough time to assert $\overline{\text{RST}}$ Low prior to VDD falling below 3.0 V. Figure 3 on page 16 shows the resulting waveform of the circuit shown in Figure 2 on page 16.
