Stellaris® LM3S3634 RevA0 Errata

This document contains known errata at the time of publication for the Stellaris LM3S3634 microcontroller. The table below summarizes the errata and lists the affected revisions. See the data sheet for more details.

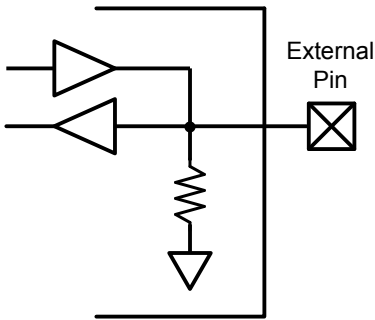
Figure 1. Internal Structure of PB0 and PB1

7.2 PB0 and PB1 have permanent internal pull-down resistance

Description:

Regardless of their configuration, PB0 and PB1 have an internal pull-down resistance. The internal structure of these pins is shown in Figure 1 on page 12.

When either of these pins is configured as an input, the external circuit must provide enough drive strength to over-drive the internal pull-down and achieve the necessary V_{IH} voltage level. If an external pull-up resistor is used, it must have a low value such as $\sim 1\text{ K}\Omega$ or less for PB0 and $\sim 50\text{ K}\Omega$ or less for PB1.

When either of these pins is configured as an output, the drive current needed to over-drive the internal pull-down resistance must be subtracted from the drive capabilities of the pin. In some applications, it may be necessary to select a higher drive strength (such as 4 mA instead of 2 mA) to achieve an acceptable output voltage on PB0.

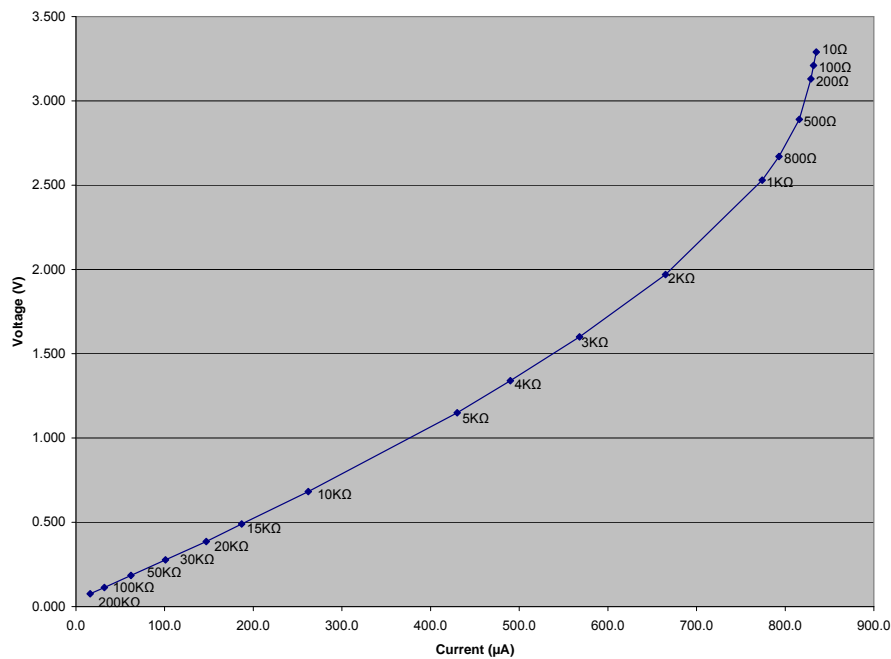
Figure 2. Voltage vs. Current for Various External Pull-up Resistors on PB0

The characteristic of the pull-down for PB0 is shown in Figure 2 on page 12. The data labels for each data point show the external pull-up resistance in Ohms.

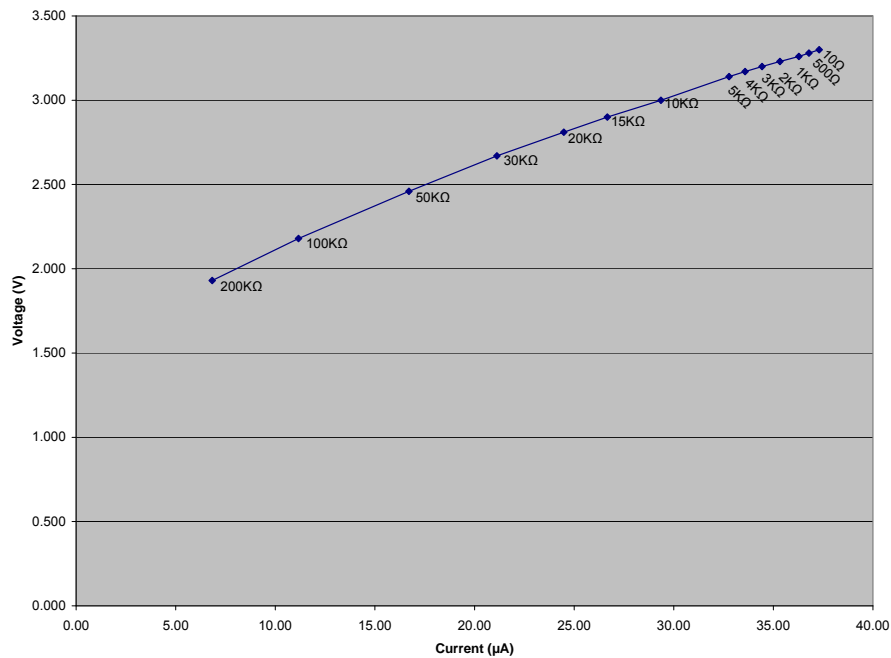
Figure 3. Voltage vs. Current for Various External Pull-up Resistors on PB1

The characteristic of the pull-down for PB1 is shown in Figure 3 on page 13. The data labels for each data point show the equivalent resistance in Ohms.
