Stellaris® LM3S9B90 RevC3 Errata

This document contains known errata at the time of publication for the Stellaris LM3S9B90 microcontroller. The table below summarizes the errata and lists the affected revisions. See the data sheet for more details.

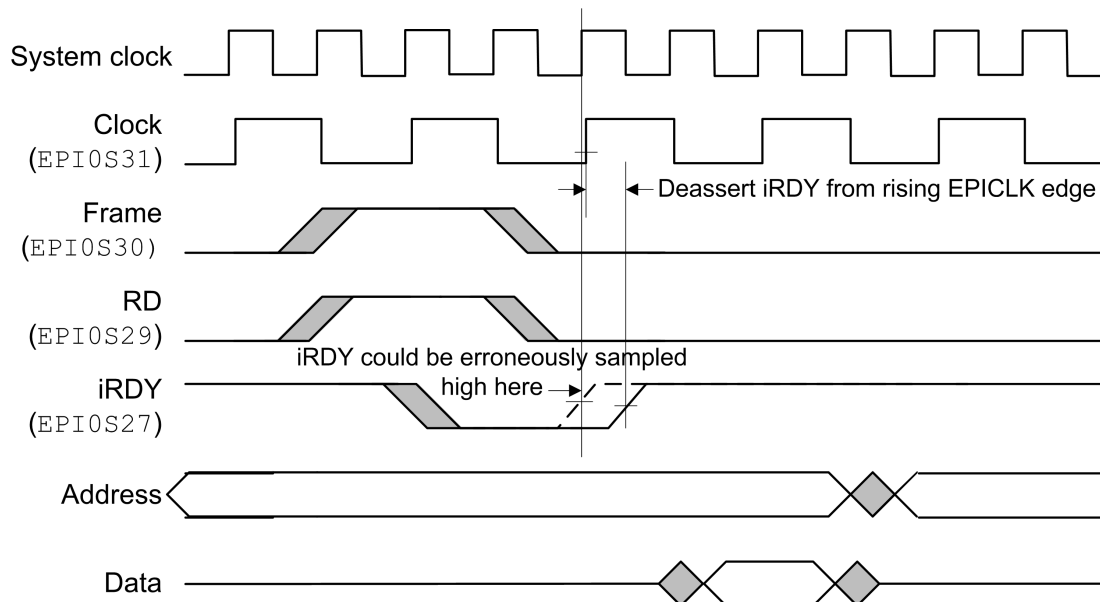
Figure 9. iRDY Timing

For example, if the system clock frequency is configured for 80 MHz (12.5 ns period) and the EPI clock frequency is configured for 40 MHz (25 ns period), there is a 2.5 ns window $((25 \text{ ns} - 12.5 \text{ ns}) - 10 \text{ ns})$, where 10 ns is the iRDY assertion or deassertion set up time (TRDYSU)) where the iRDY signal may be asserted. Figure 9 on page 30 shows where iRDY is actually sampled when trying to stall the data phase. iRDY should be deasserted after the next falling edge of EPICLK. iRDY could be erroneously sampled high if it is deasserted at the dotted line.

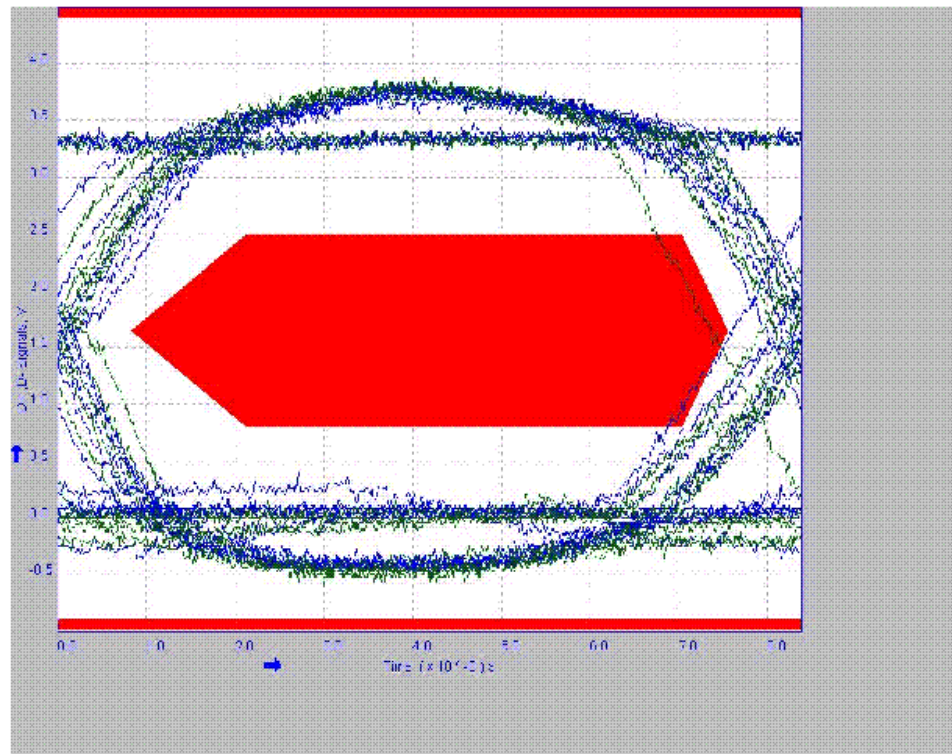
Figure 10. Example of USB Certification Failure

If the EPI module is operating, the USB interface may fail USB certification. Failures have been seen for the eye diagram and jitter (see Figure 10 on page 45). Because of these issues, there is a potential for data corruption on the USB interface when using the USB and EPI at the same time. The risk of data corruption is small, but is dependent on the system design.

- Signal eye:
Eye Diagram Test fails

- EOP width: 169.0995ns
EOP width passes
- Receivers: reliable operation on tier Tier 6
Receivers pass
- Measured Signalling Rate: 11.92707Mbps
signal rate conditionally passes
- Crossover voltage range: 1.546667 V to 1.680000 V
Mean crossover = 1.615889 V
First crossover at 1.660000 V(11 other differential crossovers checked)
crossover voltages pass
- Consecutive jitter range: -165.1885ns to 1.811468ns, RMS jitter 52.27256ns
Paired JK jitter range: 752.3810ps to 2.871429ns, RMS jitter 1.821542ns
Paired KJ jitter range: 1.185714ns to 2.168571ns, RMS jitter 1.695397ns
jitter fails

USB certification can be attained if an application does not require the USB and the EPI to be operating simultaneously. Customers who do not intend to pursue USB certification should determine if their application can handle the resulting small amount of error.
