Stellaris[®] LM3S5P3B RevC3 Errata

This document contains known errata at the time of publication for the Stellaris LM3S5P3B microcontroller. The table below summarizes the errata and lists the affected revisions. See the data sheet for more details.

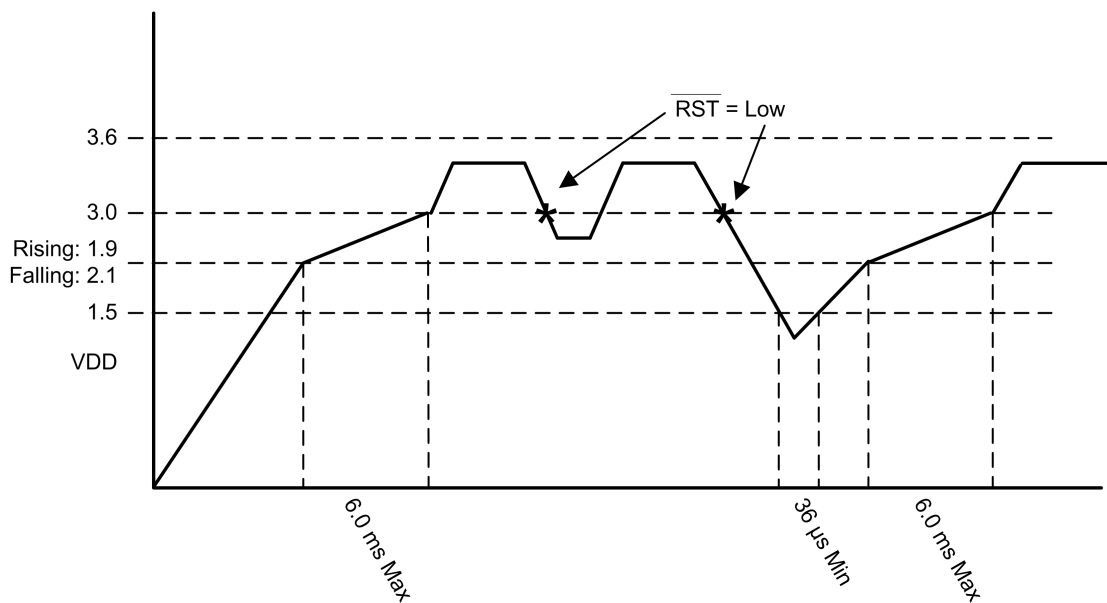
Figure 1. VDD Waveform Signature Limits

4. Once steady-state operation between 3.0 V and 3.6 V is achieved, $\overline{\text{RST}}$ must go Low or the CPU execution must be halted prior to VDD falling below 3.0 V.
5. The **Brown-Out Reset Control (PBORCTL)** register must be set so that a brown-out event causes a reset.

Depending on the system environment requirement, items 3, 4, and 5 in the above list may be met by using a voltage supervisor, such as the TLV803M, to monitor a higher voltage rail from which the VDD supply is regulated. Figure 2 on page 14 shows this implementation with a voltage supervisor monitoring the 5-V rail and a voltage trip point of 4.38 V. A voltage supervisor with a lower voltage trip point can be used to monitor the VDD (3.3-V) rail, however this supervisor must assert reset before VDD reaches 3.0 V. Regardless of the implemented voltage supervisor circuit, the system designer must ensure that there is enough time to assert $\overline{\text{RST}}$ Low prior to VDD falling below 3.0 V. Figure 3 on page 14 shows the resulting waveform of the circuit shown in Figure 2 on page 14.

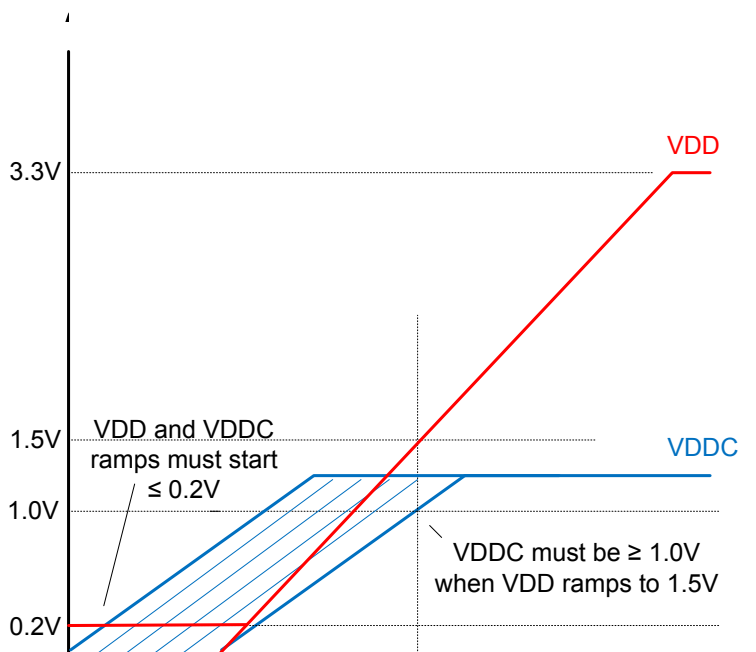
Figure 5. V_{DDC} and V_{DD} Rise Time Relationships

There is a small risk of flash corruption or device failure on power up. The issue can occur with certain V_{DD} and V_{DDC} power sequences. The failure is not in the flash memory itself but in the control logic to the flash.

this timing requirement are met. The 1.2 V regulator has an integrated Power-OK (POK) circuit that is used to enable V_{DD} when V_{DDC} reaches 1.08 V. During power-down or transient conditions, the POK circuit disables the load switch if V_{DDC} drops below 1.02 V or V_{DD} drops below 1.5 V. The load switch has an internal clamp to accelerate V_{DD} decay.
