Stellaris® LM3S1F11 RevA1 Errata

This document contains known errata at the time of publication for the Stellaris LM3S1F11 microcontroller. The table below summarizes the errata and lists the affected revisions. See the data sheet for more details.

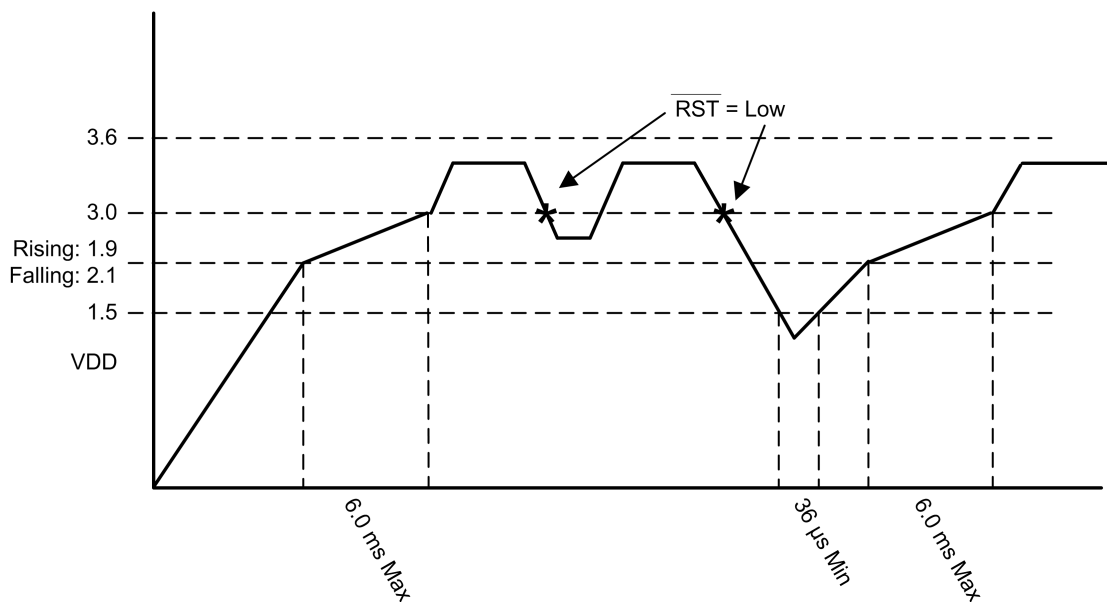
Figure 1. VDD Waveform Signature Limits

2. The power-up transition of VDD between 1.9 V and 3.0 V must not have any points where it decreases in voltage (must be monotonic).
3. The power-down transition of VDD between 3.0 V and 1.5 V must not have any points where it increases in voltage (must be monotonic).
4. Once steady-state operation between 3.0 V and 3.6 V is achieved, $\overline{\text{RST}}$ must go Low or the CPU execution must be halted prior to VDD falling below 3.0 V.
5. The **Brown-Out Reset Control (PBORCTL)** register must be set so that a brown-out event causes a reset.

Depending on the system environment requirement, items 3, 4, and 5 in the above list may be met by using a voltage supervisor, such as the TLV803M, to monitor a higher voltage rail from which the VDD supply is regulated. Figure 2 on page 14 shows this implementation with a voltage supervisor monitoring the 5-V rail and a voltage trip point of 4.38 V. A voltage supervisor with a lower voltage trip point can be used to monitor the VDD (3.3-V) rail, however this supervisor must assert reset before VDD reaches 3.0 V. Regardless of the implemented voltage supervisor circuit, the system designer must ensure that there is enough time to assert $\overline{\text{RST}}$ Low prior to VDD falling below 3.0 V. Figure 3 on page 14 shows the resulting waveform of the circuit shown in Figure 2 on page 14.

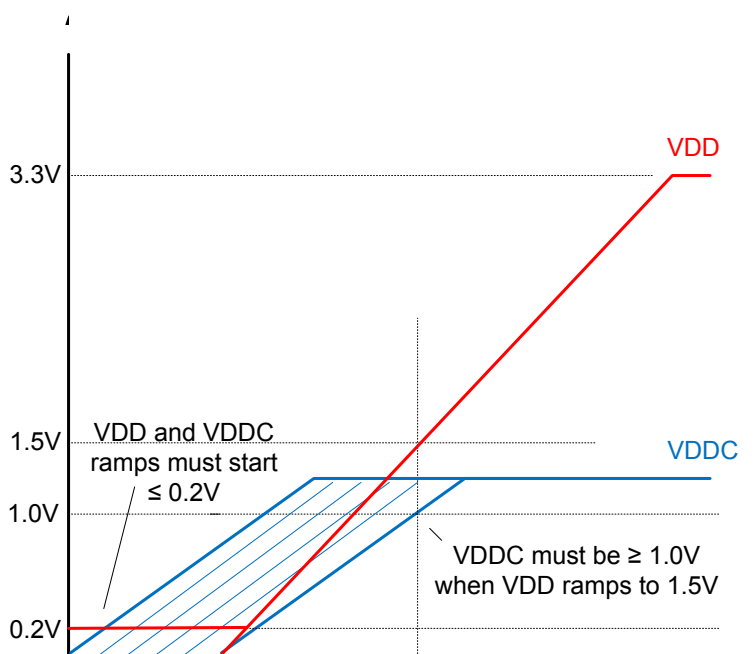
Figure 5. V_{DDC} and V_{DD} Rise Time Relationships

There is a small risk of flash corruption or device failure on power up. The issue can occur with certain V_{DD} and V_{DDC} power sequences. The failure is not in the flash memory itself but in the control logic to the flash.

Normally V_{DDC} is supplied by the device's internal voltage regulator from the LDO output pin, however in some circuits the internal regulator may not meet this V_{DDC} timing requirement. A circuit combining an external 1.2 V regulator, a voltage supervisor and a power switch can be used to ensure that this timing requirement are met. The 1.2 V regulator has an integrated Power-OK (POK) circuit that is used to enable V_{DD} when V_{DDC} reaches 1.08 V. During power-down or transient conditions, the POK circuit disables the load switch if V_{DDC} drops below 1.02 V or V_{DD} drops below 1.5 V. The load switch has an internal clamp to accelerate V_{DD} decay.

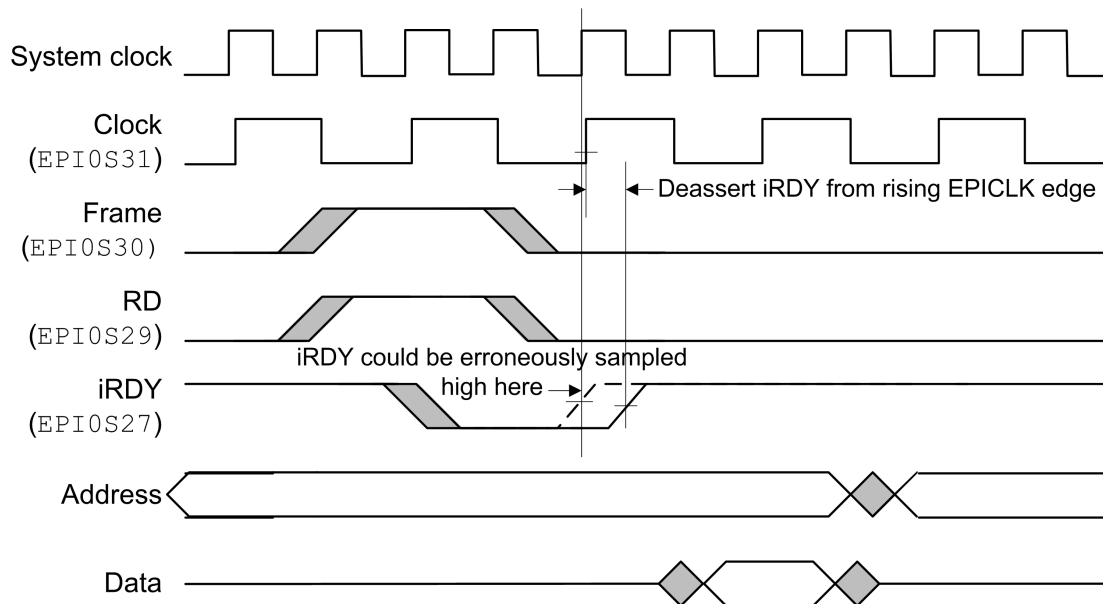
Figure 9. iRDY Timing

For example, if the system clock frequency is configured for 80 MHz (12.5 ns period) and the EPI clock frequency is configured for 40 MHz (25 ns period), there is a 2.5 ns window $((25 \text{ ns} - 12.5 \text{ ns}) - 10 \text{ ns})$, where 10 ns is the iRDY assertion or deassertion set up time (TRDYSU)) where the iRDY signal may be asserted. Figure 9 on page 30 shows where iRDY is actually sampled when trying to stall the data phase. iRDY should be deasserted after the next falling edge of EPICLK. iRDY could be erroneously sampled high if it is deasserted at the dotted line.
