Stellaris® LM3S5C31 RevA1 Errata

This document contains known errata at the time of publication for the Stellaris LM3S5C31 microcontroller. The table below summarizes the errata and lists the affected revisions. See the data sheet for more details.

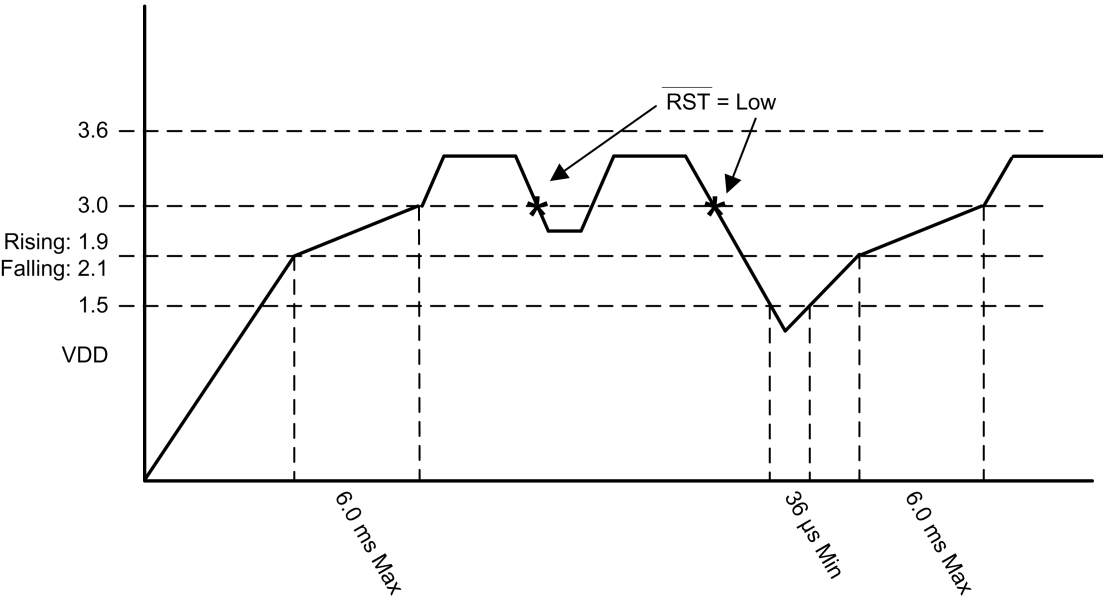
Figure 1. VDD Waveform Signature Limits

Depending on the system environment requirement, items 3, 4, and 5 in the above list may be met by using a voltage supervisor, such as the TLV803M, to monitor a higher voltage rail from which the VDD supply is regulated. Figure 2 on page 14 shows this implementation with a voltage supervisor monitoring the 5-V rail and a voltage trip point of 4.38 V. A voltage supervisor with a lower voltage trip point can be used to monitor the VDD (3.3-V) rail, however this supervisor must assert reset before VDD reaches 3.0 V. Regardless of the implemented voltage supervisor circuit, the system designer must ensure that there is enough time to assert $\overline{\text{RST}}$ Low prior to VDD falling below 3.0 V. Figure 3 on page 15 shows the resulting waveform of the circuit shown in Figure 2 on page 14.

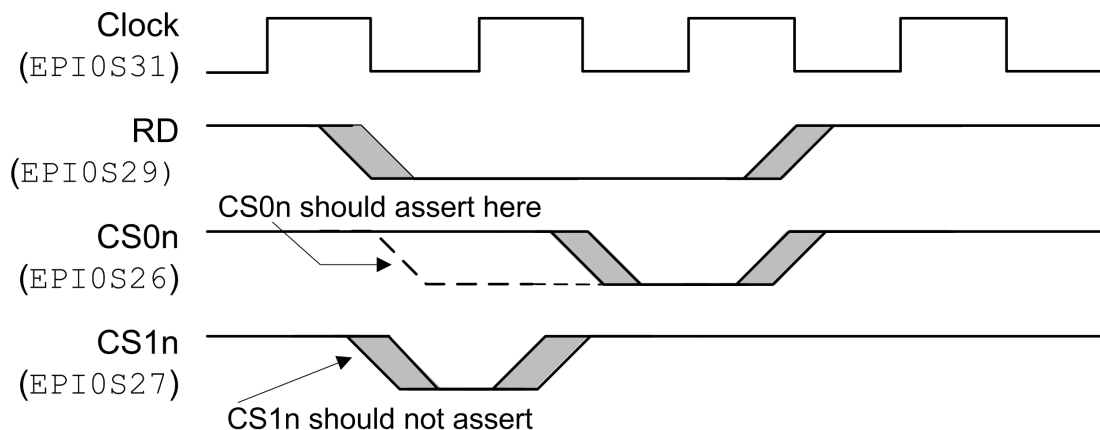
Figure 4. Chip Selects

For example, if the peripheral requires a read strobe that is 4 EPI clocks wide, set the `MODE` field to be 0x2 (6 clocks) to account for the 1 clock difference in the strobe width.

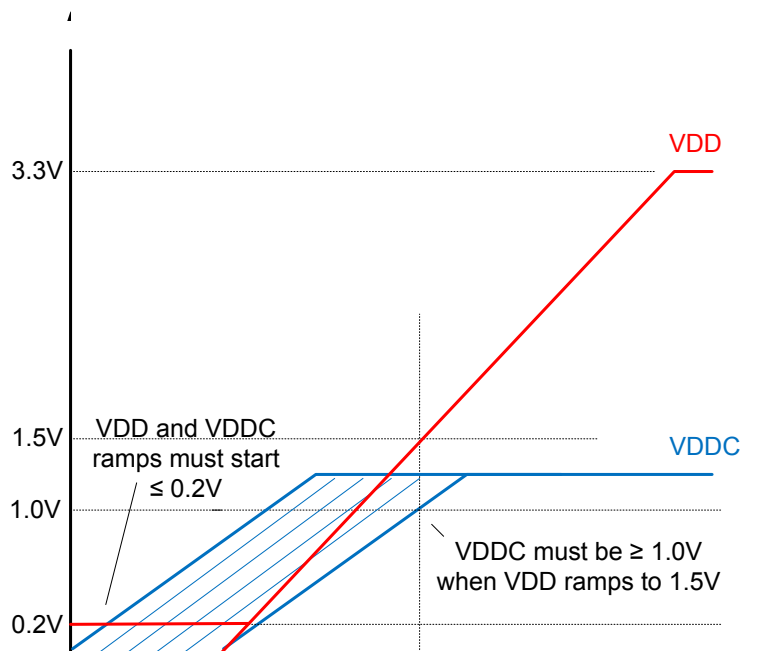
Figure 5. V_{DDC} and V_{DD} Rise Time Relationships

There is a small risk of flash corruption or device failure on power up. The issue can occur with certain V_{DD} and V_{DDC} power sequences. The failure is not in the flash memory itself but in the control logic to the flash.

Normally V_{DDC} is supplied by the device's internal voltage regulator from the LDO output pin, however in some circuits the internal regulator may not meet this V_{DDC} timing requirement. A circuit combining an external 1.2 V regulator, a voltage supervisor and a power switch can be used to ensure that this timing requirement are met. The 1.2 V regulator has an integrated Power-OK (POK) circuit that is used to enable V_{DD} when V_{DDC} reaches 1.08 V. During power-down or transient conditions, the POK circuit disables the load switch if V_{DDC} drops below 1.02 V or V_{DD} drops below 1.5 V. The load switch has an internal clamp to accelerate V_{DD} decay.

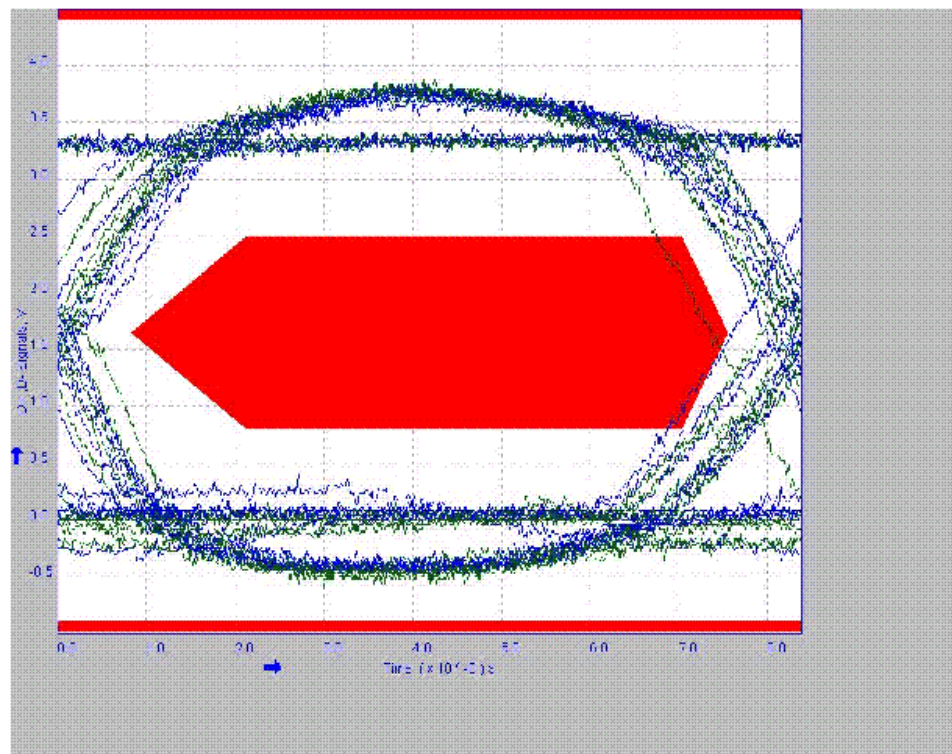
Figure 10. Example of USB Certification Failure

If the EPI module is operating, the USB interface may fail USB certification. Failures have been seen for the eye diagram and jitter (see Figure 10 on page 43). Because of these issues, there is a potential for data corruption on the USB interface when using the USB and EPI at the same time. The risk of data corruption is small, but is dependent on the system design.

- Signal eye:
Eye Diagram Test fails

- EOP width: 169.0995ns
EOP width passes
- Receivers: reliable operation on tier Tier 6
Receivers pass
- Measured Signalling Rate: 11.92707Mbps
signal rate conditionally passes
- Crossover voltage range: 1.546667 V to 1.680000 V
Mean crossover = 1.615889 V
First crossover at 1.660000 V(11 other differential crossovers checked)
crossover voltages pass
- Consecutive jitter range: -165.1885ns to 1.811468ns, RMS jitter 52.27256ns
Paired JK jitter range: 752.3810ps to 2.871429ns, RMS jitter 1.821542ns
Paired KJ jitter range: 1.185714ns to 2.168571ns, RMS jitter 1.695397ns
jitter fails

USB certification can be attained if an application does not require the USB and the EPI to be operating simultaneously. Customers who do not intend to pursue USB certification should determine if their application can handle the resulting small amount of error.
