## Stellaris® LM3S5C56 RevA1 Errata

This document contains known errata at the time of publication for the Stellaris LM3S5C56 microcontroller. The table below summarizes the errata and lists the affected revisions. See the data sheet for more details.

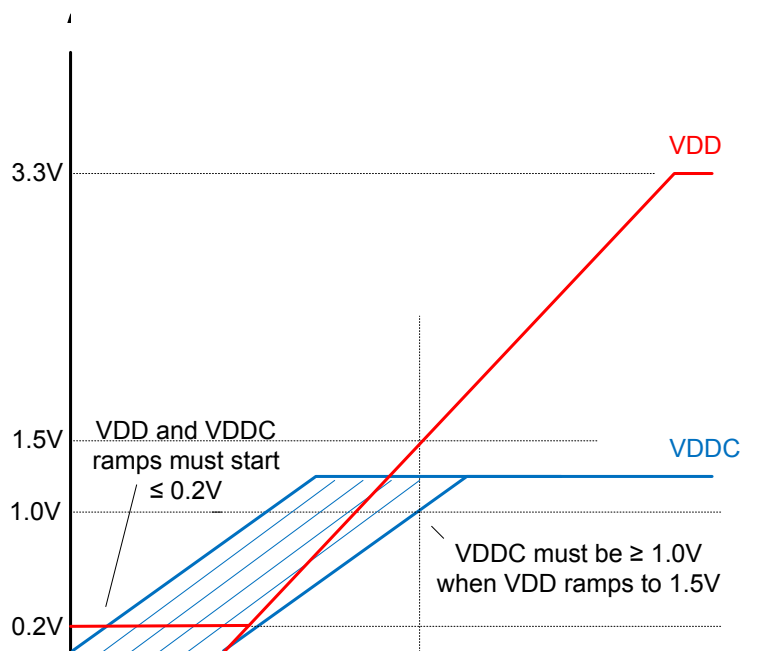
Figure 5.  $V_{DDC}$  and  $V_{DD}$  Rise Time Relationships

There is a small risk of flash corruption or device failure on power up. The issue can occur with certain  $V_{DD}$  and  $V_{DDC}$  power sequences. The failure is not in the flash memory itself but in the control logic to the flash.

Normally  $V_{DDC}$  is supplied by the device's internal voltage regulator from the LDO output pin, however in some circuits the internal regulator may not meet this  $V_{DDC}$  timing requirement. A circuit combining an external 1.2 V regulator, a voltage supervisor and a power switch can be used to ensure that this timing requirement are met. The 1.2 V regulator has an integrated Power-OK (POK) circuit that is used to enable  $V_{DD}$  when  $V_{DDC}$  reaches 1.08 V. During power-down or transient conditions, the POK circuit disables the load switch if  $V_{DDC}$  drops below 1.02 V or  $V_{DD}$  drops below 1.5 V. The load switch has an internal clamp to accelerate  $V_{DD}$  decay.
