## Stellaris<sup>®</sup> LM3S9C97 RevA1 Errata

This document contains known errata at the time of publication for the Stellaris LM3S9C97 microcontroller. The table below summarizes the errata and lists the affected revisions. See the data sheet for more details.

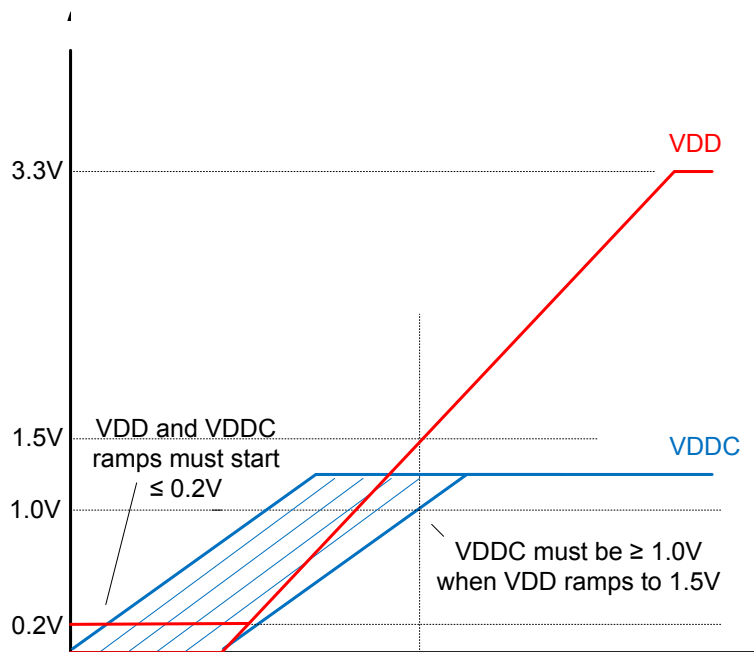
**Figure 5.  $V_{DDC}$  and  $V_{DD}$  Rise Time Relationships**

There is a small risk of flash corruption or device failure on power up. The issue can occur with certain  $V_{DD}$  and  $V_{DDC}$  power sequences. The failure is not in the flash memory itself but in the control logic to the flash.

Normally  $V_{DDC}$  is supplied by the device's internal voltage regulator from the LDO output pin, however in some circuits the internal regulator may not meet this  $V_{DDC}$  timing requirement. A circuit combining an external 1.2 V regulator, a voltage supervisor and a power switch can be used to ensure that this timing requirement are met. The 1.2 V regulator has an integrated Power-OK (POK) circuit that is used to enable  $V_{DD}$  when  $V_{DDC}$  reaches 1.08 V. During power-down or transient conditions, the POK circuit disables the load switch if  $V_{DDC}$  drops below 1.02 V or  $V_{DD}$  drops below 1.5 V. The load switch has an internal clamp to accelerate  $V_{DD}$  decay.
