## Stellaris<sup>®</sup> LM3S9D90 RevA1 Errata

This document contains known errata at the time of publication for the Stellaris LM3S9D90 microcontroller. The table below summarizes the errata and lists the affected revisions. See the data sheet for more details.

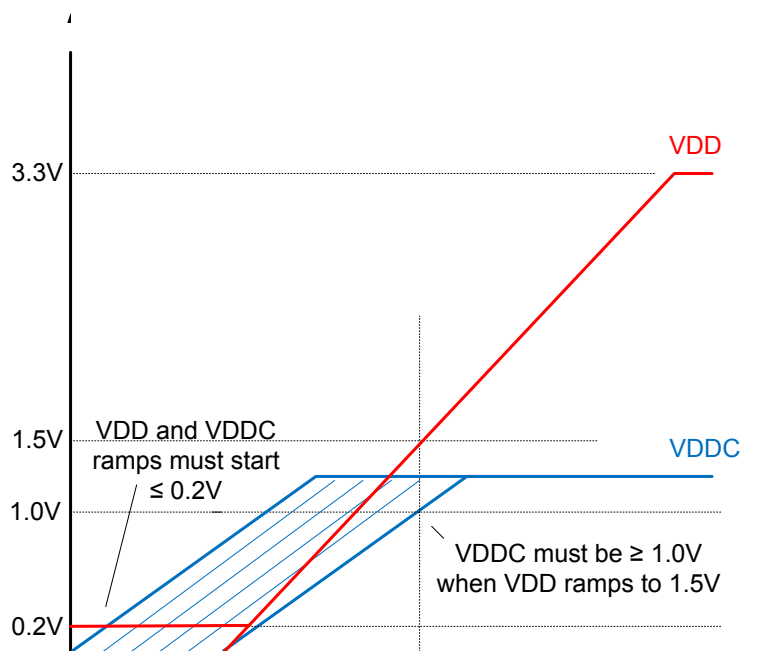
Figure 5.  $V_{DDC}$  and  $V_{DD}$  Rise Time Relationships

## 5.5 Flash corruption or device failure may occur at power on

There is a small risk of flash corruption or device failure on power up. The issue can occur with certain  $V_{DD}$  and  $V_{DDC}$  power sequences. The failure is not in the flash memory itself but in the control logic to the flash.

Normally  $V_{DDC}$  is supplied by the device's internal voltage regulator from the LDO output pin, however in some circuits the internal regulator may not meet this  $V_{DDC}$  timing requirement. A circuit combining an external 1.2 V regulator, a voltage supervisor and a power switch can be used to ensure that this timing requirement are met. The 1.2 V regulator has an integrated Power-OK (POK) circuit that is used to enable  $V_{DD}$  when  $V_{DDC}$  reaches 1.08 V. During power-down or transient conditions, the POK circuit disables the load switch if  $V_{DDC}$  drops below 1.02 V or  $V_{DD}$  drops below 1.5 V. The load switch has an internal clamp to accelerate  $V_{DD}$  decay.

When implementing this workaround, it is important to consider all possible power conditions for the system, including:

Three recommended circuits that eliminate the occurrence of this issue are shown below. Although the LDO regulator output is unused in the workaround circuit, a capacitor (1-3  $\mu F$ ) must remain connected for regulator stability. In addition, the  $LDO$  pin of the Stellaris device must be disconnected from the external 1.2 V LDO to prevent electronic over stress of the pin. All of these circuits include two jumpers which must be implemented to bypass the workaround circuit for future silicon revisions.

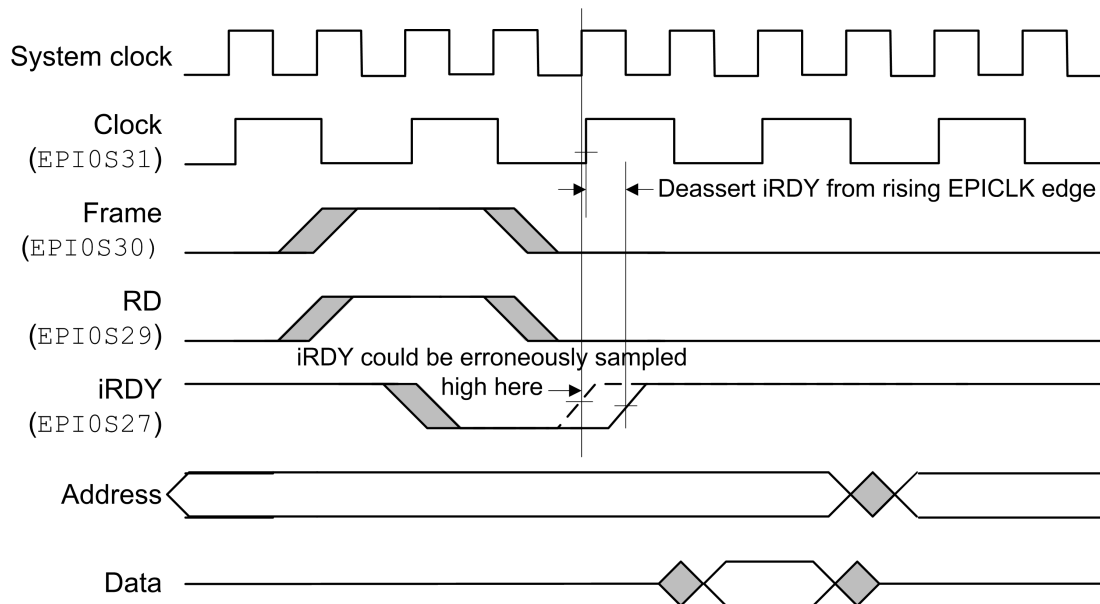
**Figure 9. iRDY Timing**

For example, if the system clock frequency is configured for 80 MHz (12.5 ns period) and the EPI clock frequency is configured for 40 MHz (25 ns period), there is a 2.5 ns window  $((25 \text{ ns} - 12.5 \text{ ns}) - 10 \text{ ns})$ , where 10 ns is the iRDY assertion or deassertion set up time (TRDYSU)) where the iRDY signal may be asserted. Figure 9 on page 30 shows where iRDY is actually sampled when trying to stall the data phase. iRDY should be deasserted after the next falling edge of EPICLK. iRDY could be erroneously sampled high if it is deasserted at the dotted line.

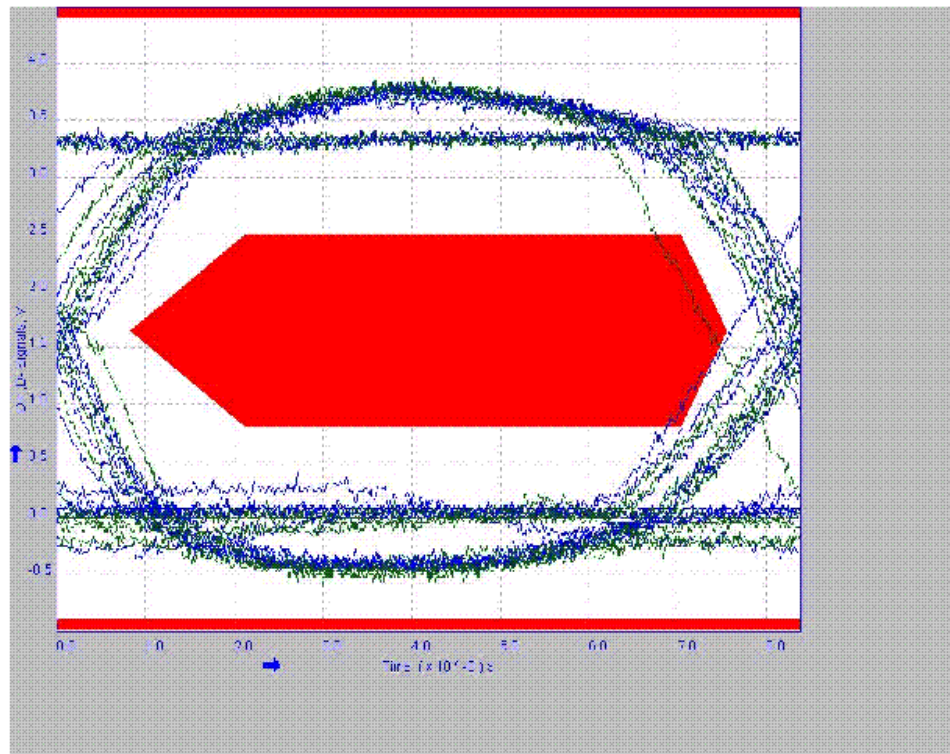
Figure 10. Example of USB Certification Failure

If the EPI module is operating, the USB interface may fail USB certification. Failures have been seen for the eye diagram and jitter (see Figure 10 on page 44). Because of these issues, there is a potential for data corruption on the USB interface when using the USB and EPI at the same time. The risk of data corruption is small, but is dependent on the system design.

- Signal eye:  
Eye Diagram Test fails

- EOP width: 169.0995ns  
EOP width passes
- Receivers: reliable operation on tier Tier 6  
Receivers pass
- Measured Signalling Rate: 11.92707Mbps  
signal rate conditionally passes
- Crossover voltage range: 1.546667 V to 1.680000 V  
Mean crossover = 1.615889 V  
First crossover at 1.660000 V(11 other differential crossovers checked)  
crossover voltages pass
- Consecutive jitter range: -165.1885ns to 1.811468ns, RMS jitter 52.27256ns  
Paired JK jitter range: 752.3810ps to 2.871429ns, RMS jitter 1.821542ns  
Paired KJ jitter range: 1.185714ns to 2.168571ns, RMS jitter 1.695397ns  
jitter fails

USB certification can be attained if an application does not require the USB and the EPI to be operating simultaneously. Customers who do not intend to pursue USB certification should determine if their application can handle the resulting small amount of error.
