## Stellaris® LM3S9D96 RevA1 Errata

This document contains known errata at the time of publication for the Stellaris LM3S9D96 microcontroller. The table below summarizes the errata and lists the affected revisions. See the data sheet for more details.

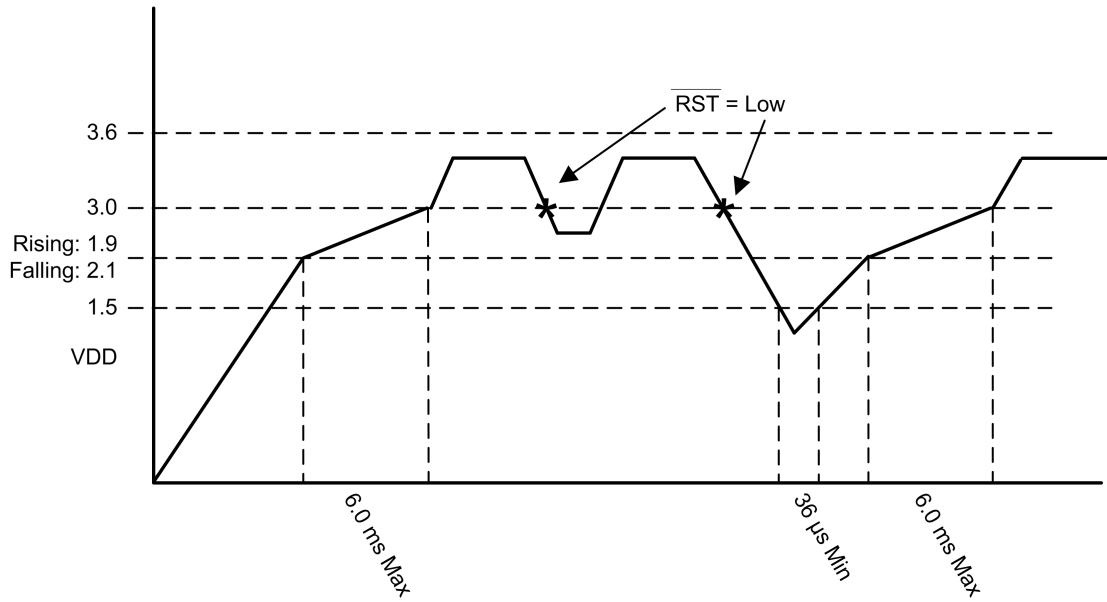
Figure 1. VDD Waveform Signature Limits

Depending on the system environment requirement, items 3, 4, and 5 in the above list may be met by using a voltage supervisor, such as the TLV803M, to monitor a higher voltage rail from which the VDD supply is regulated. Figure 2 on page 15 shows this implementation with a voltage supervisor monitoring the 5-V rail and a voltage trip point of 4.38 V. A voltage supervisor with a lower voltage trip point can be used to monitor the VDD (3.3-V) rail, however this supervisor must assert reset before VDD reaches 3.0 V. Regardless of the implemented voltage supervisor circuit, the system designer must ensure that there is enough time to assert  $\overline{\text{RST}}$  Low prior to VDD falling below 3.0 V. Figure 3 on page 16 shows the resulting waveform of the circuit shown in Figure 2 on page 15.

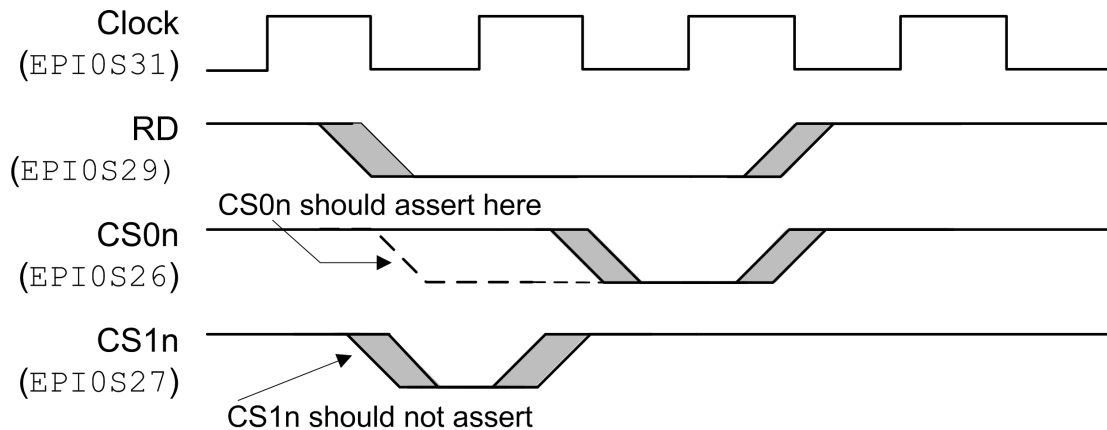
**Figure 4. Chip Selects**

For example, if the peripheral requires a read strobe that is 4 EPI clocks wide, set the `MODE` field to be 0x2 (6 clocks) to account for the 1 clock difference in the strobe width.

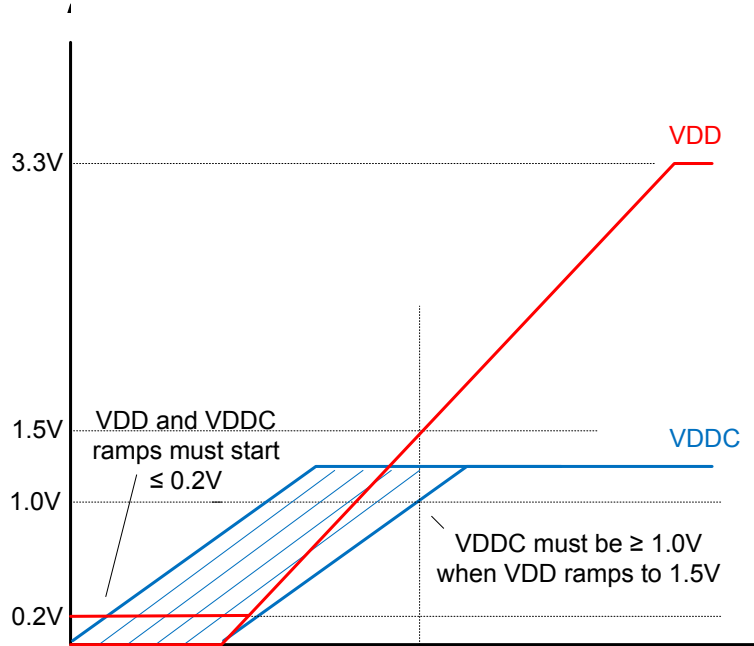
**Figure 5.  $V_{DDC}$  and  $V_{DD}$  Rise Time Relationships**

There is a small risk of flash corruption or device failure on power up. The issue can occur with certain  $V_{DD}$  and  $V_{DDC}$  power sequences. The failure is not in the flash memory itself but in the control logic to the flash.

Normally  $V_{DDC}$  is supplied by the device's internal voltage regulator from the LDO output pin, however in some circuits the internal regulator may not meet this  $V_{DDC}$  timing requirement. A circuit combining an external 1.2 V regulator, a voltage supervisor and a power switch can be used to ensure that this timing requirement are met. The 1.2 V regulator has an integrated Power-OK (POK) circuit that is used to enable  $V_{DD}$  when  $V_{DDC}$  reaches 1.08 V. During power-down or transient conditions, the POK circuit disables the load switch if  $V_{DDC}$  drops below 1.02 V or  $V_{DD}$  drops below 1.5 V. The load switch has an internal clamp to accelerate  $V_{DD}$  decay.

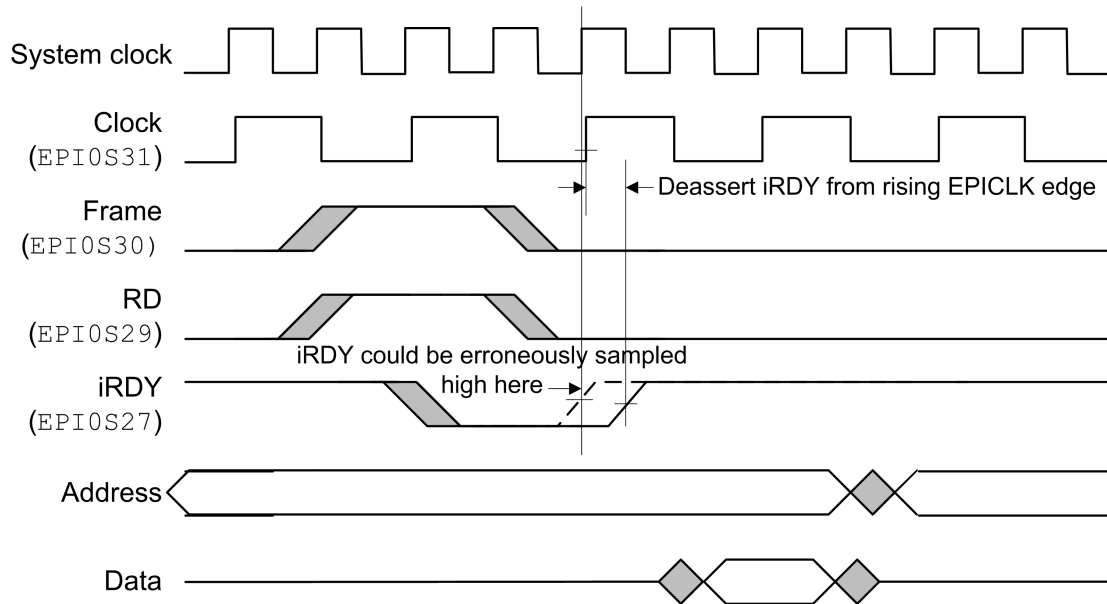
**Figure 9. iRDY Timing**

For example, if the system clock frequency is configured for 80 MHz (12.5 ns period) and the EPI clock frequency is configured for 40 MHz (25 ns period), there is a 2.5 ns window  $((25\text{ ns} - 12.5\text{ ns}) - 10\text{ ns})$ , where 10 ns is the iRDY assertion or deassertion set up time (TRDYSU)) where the iRDY signal may be asserted. Figure 9 on page 29 shows where iRDY is actually sampled when trying to stall the data phase. iRDY should be deasserted after the next falling edge of EPICLK. iRDY could be erroneously sampled high if it is deasserted at the dotted line.

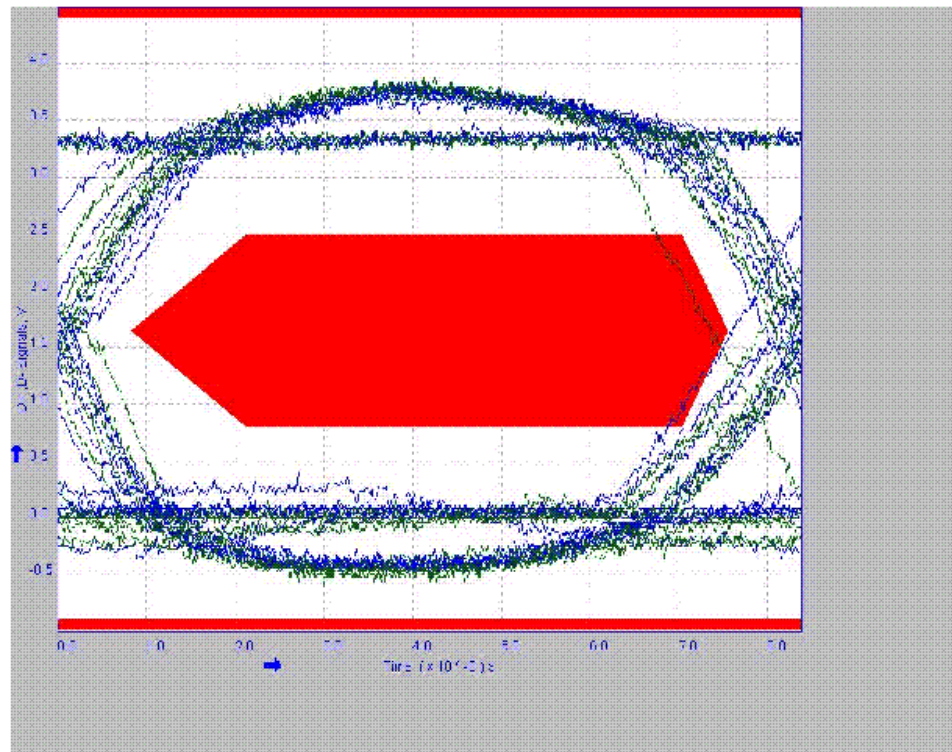
**Figure 10. Example of USB Certification Failure**

If the EPI module is operating, the USB interface may fail USB certification. Failures have been seen for the eye diagram and jitter (see Figure 10 on page 43). Because of these issues, there is a potential for data corruption on the USB interface when using the USB and EPI at the same time. The risk of data corruption is small, but is dependent on the system design.

- Signal eye:  
Eye Diagram Test fails

- EOP width: 169.0995ns  
EOP width passes
- Receivers: reliable operation on tier Tier 6  
Receivers pass
- Measured Signalling Rate: 11.92707Mbps  
signal rate conditionally passes
- Crossover voltage range: 1.546667 V to 1.680000 V  
Mean crossover = 1.615889 V  
First crossover at 1.660000 V(11 other differential crossovers checked)  
crossover voltages pass
- Consecutive jitter range: -165.1885ns to 1.811468ns, RMS jitter 52.27256ns  
Paired JK jitter range: 752.3810ps to 2.871429ns, RMS jitter 1.821542ns  
Paired KJ jitter range: 1.185714ns to 2.168571ns, RMS jitter 1.695397ns  
jitter fails

USB certification can be attained if an application does not require the USB and the EPI to be operating simultaneously. Customers who do not intend to pursue USB certification should determine if their application can handle the resulting small amount of error.
