Stellaris® LM3S1F11 RevA2 Errata

This document contains known errata at the time of publication for the Stellaris LM3S1F11 microcontroller. The table below summarizes the errata and lists the affected revisions. See the data sheet for more details.

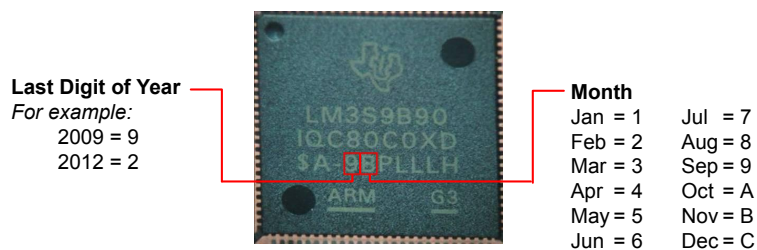
Note: To determine the date code of your part, look at the first two characters following the dash on the third line of the part markings (highlighted in red in the following figure). The first number after the dash indicates the last decimal digit of the year. The second character indicates the month. Therefore, the following example shows a date code of 9B which indicates November 2009.
