## Stellaris® LM3S1C21 RevA2 Errata

This document contains known errata at the time of publication for the Stellaris LM3S1C21 microcontroller. The table below summarizes the errata and lists the affected revisions. See the data sheet for more details.

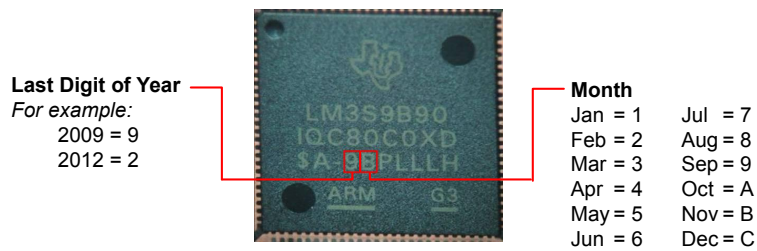
**Note:** To determine the date code of your part, look at the first two characters following the dash on the third line of the part markings (highlighted in red in the following figure). The first number after the dash indicates the last decimal digit of the year. The second character indicates the month. Therefore, the following example shows a date code of 9B which indicates November 2009.
