**TMS320F2810, TMS320F2811, TMS320F2812**  
**TMS320C2810, TMS320C2811, TMS320C2812**  
**DSP Silicon Errata**

*SPRZ193L*  
January 2003 – Revised March 2009

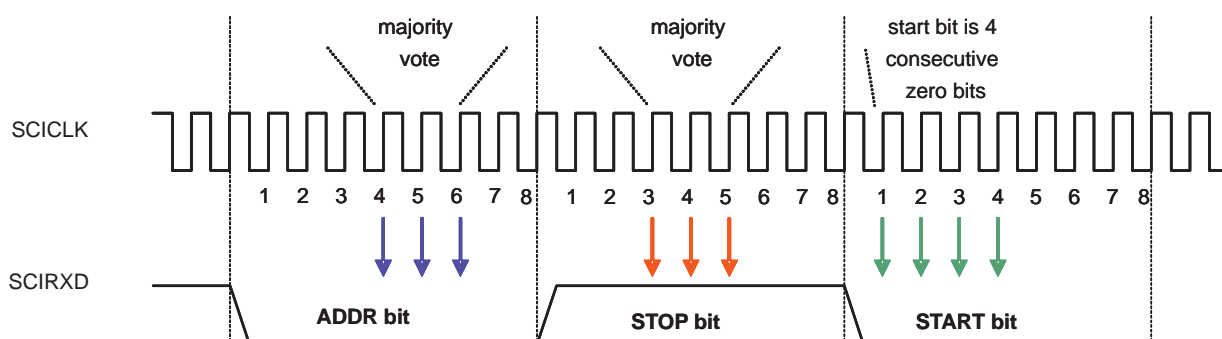
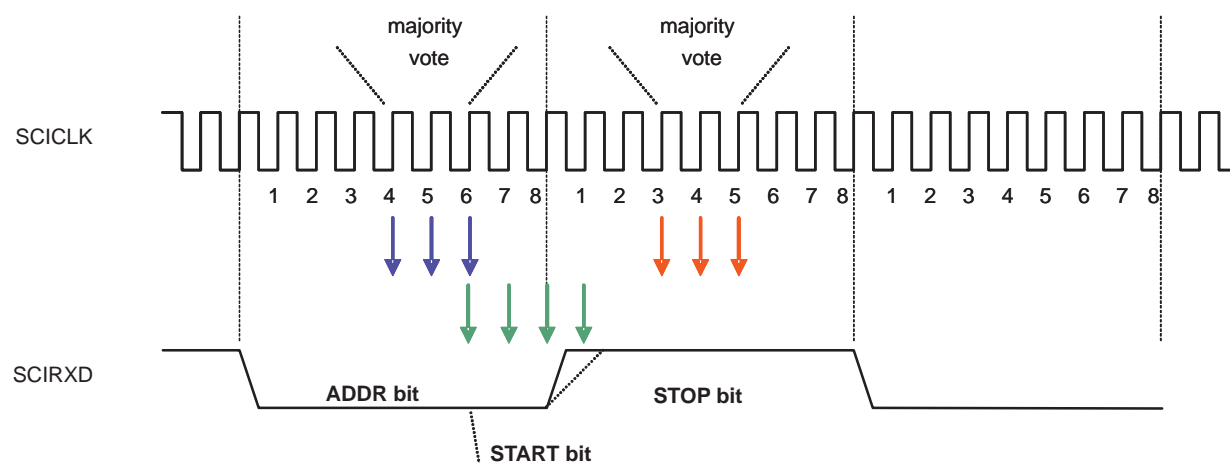
**Figure 2. Difference Between Expected and Erroneous Operation of START Bit**

**Details:** SCI does not look for STOP bit after the ADDR bit. Instead, SCI starts looking for the start bit beginning on sub-sample 6 of the ADDR bit. Slow rise-time from ADDR to STOP bit can cause false START bit to occur since 4th sub-sample for the start bit may be sensed low.

**Workaround:** Program the baud rate of the SCI to be slightly slower than the actual. This will cause the 4th sub-sample of the false START bit to be delayed in time, and therefore occur more towards the middle of the STOP bit (away from the signal transition region). The amount of baud slowing needed depends on the rise-time of the signal in the system. Alternatively, IDLE mode of the SCI module may be used, if applicable.
