# **TMS320R2811 and TMS320R2812**

## **Digital Signal Processors**

### **Silicon Errata**

*SPRZ226C*  
June 2004 – Revised March 2009

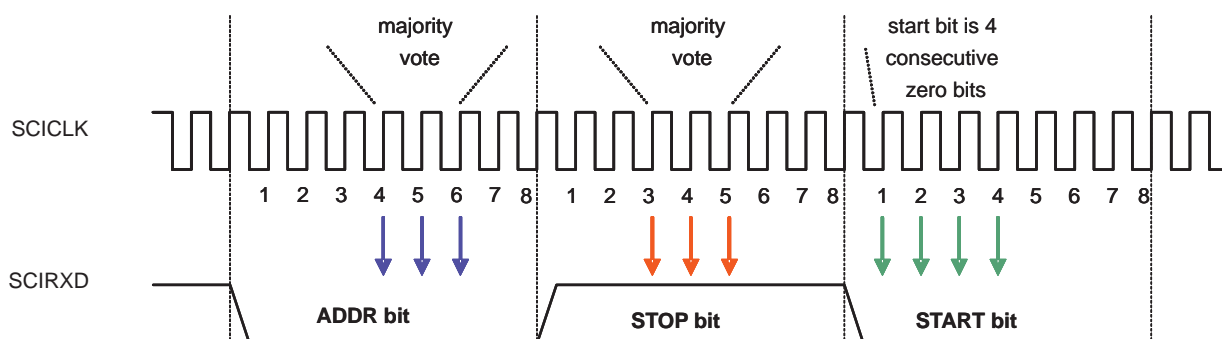
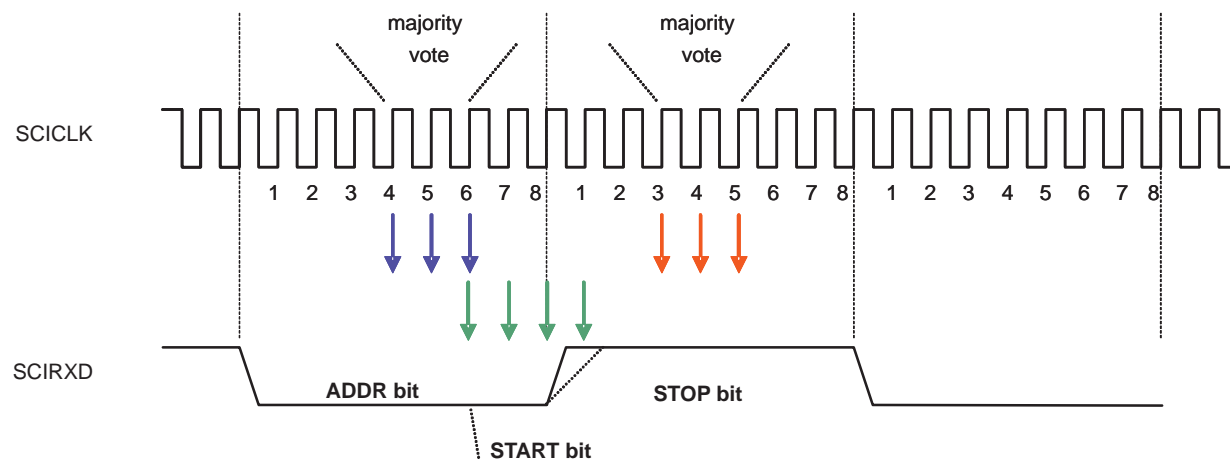
**Figure 2. Difference Between Expected and Erroneous Operation of START Bit**

**Advisory***SCI: Incorrect Operation of SCI in Address Bit Mode***Revision(s) Affected:** 0, A, B

**Details:** SCI does not look for STOP bit after the ADDR bit. Instead, SCI starts looking for the start bit beginning on sub-sample 6 of the ADDR bit. Slow rise time from ADDR to STOP bit can cause false START bit to occur since fourth sub-sample for the start bit may be sensed low.

**Workaround:** Program the baud rate of the SCI to be slightly slower than the actual. This will cause the fourth sub-sample of the false START bit to be delayed in time, and therefore occur more towards the middle of the STOP bit (away from the signal transition region). The amount of baud slowing needed depends on the rise time of the signal in the system. Alternatively, IDLE mode of the SCI module may be used, if applicable.
