TMS320C6748 Fixed/Floating-Point DSP Silicon Revisions 2.1, 2.0, 1.1 and 1.0

Silicon Errata

Literature Number: SPRZ303G
June 2009–Revised October 2013

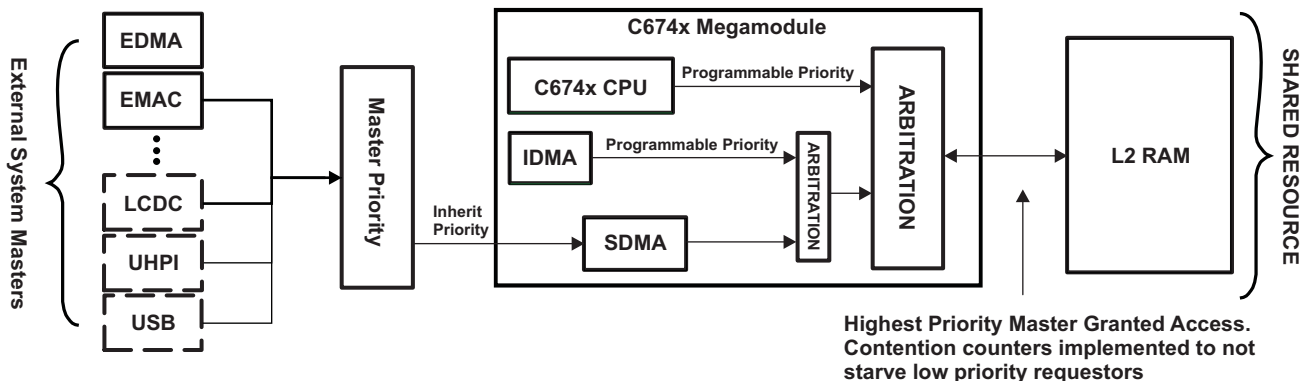
Figure 3. Priority Arbitration Scheme for L2 RAM

Ideally, the BWM arbitration will grant equal L2 bandwidth between equal priority DMA and CPU requests. Instead, when equal priority DMA and CPU requests arrive at the BWM, bandwidth is always granted in favor of the CPU over DMA. In the case of successive CPU requests, it is possible for the CPU to block all DMA requests until CPU traffic subsides. Additionally, some command logic in the BWM uses priority level 7, which can also result in SDMA stalls when the CPU is also programmed to priority level 7. [Figure 3](#) shows a high level diagram of the arbitration scheme used for L2 RAM requests.

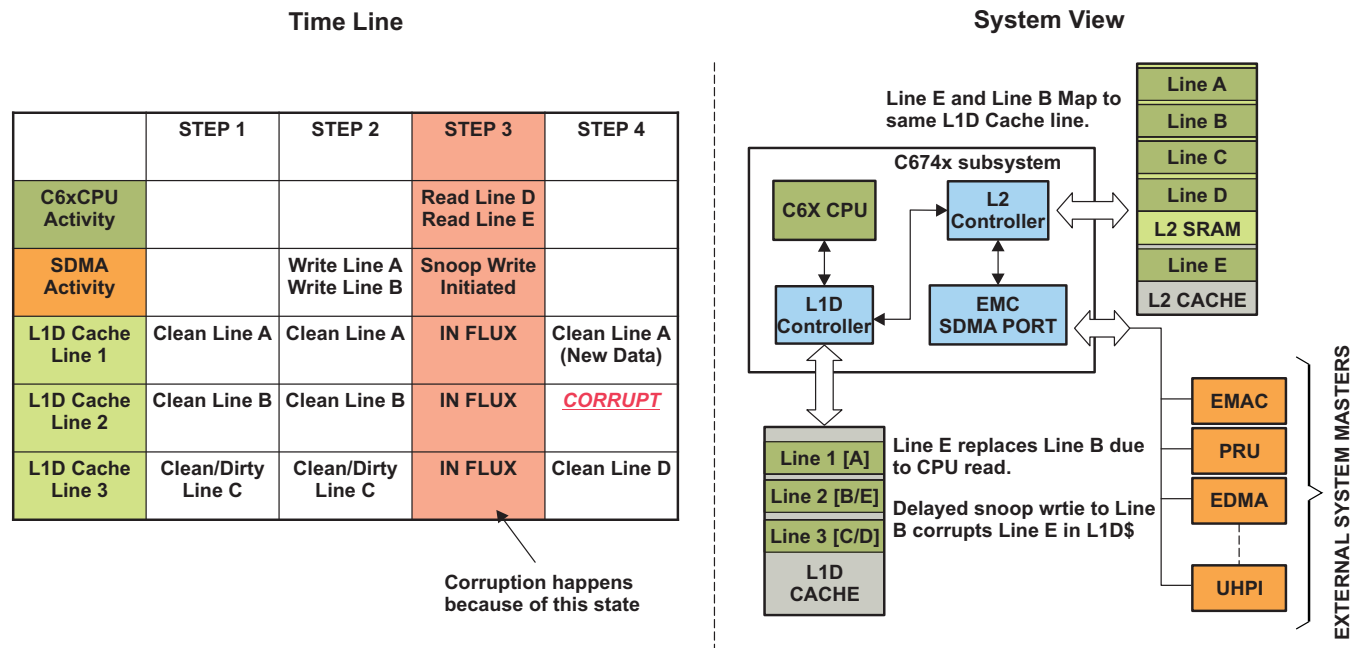
Figure 4. Example of L1D Cache Corruption

An L1D cache-line corruption event occurs when all of the conditions in the following steps are met (see [Figure 4](#)):

- Line E in L2 cache is read as a cache hit. Line E is destined to replace Line 2 in L1D Cache, which also has a snoop write pending for the updated Line B content.

- Line D in L2 SRAM is read. Line D will replace Line 3 in L1D cache.
4. When the snoop write operation completes, Line 2 in L1D cache now contains the updated L2 SRAM Line B data instead of the L2 cache Line E data.

The correct behavior would have been to kill the pending snoop write initiated to update L1D cache Line 2 with the updated L2 SRAM Line B data in Step 3. The L1D cache should have evicted Line B and replaced it with Line E data. Instead, the snoop write operation continues and does not complete until after the L1D cache Line 2 has already been replaced with L2 cache Line E data. The snoop write instruction overwrites the L1D cache Line 2 (containing L2 cache Line E data) with the updated L2 SRAM Line B data.

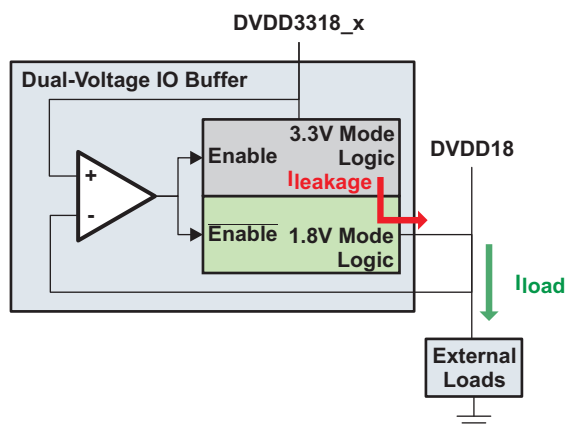
Figure 8. Error State of the IO buffer during Zone G

Error State of the IO buffer during Zone G:

As DVDD3318_x exceeds DVDD18 + V_T , some of the circuitry across the boundary of the two voltage domains will turn on and causes a leakage current (in red) to flow between the two voltage domains. This current pulls up the DVDD18 supply unless the power source providing that supply can oppose it or unless the load current is strong enough to counteract it.

If DVDD18 continues to rise as DVDD3318_x ramps, the comparator never sees enough difference between the two supplies to switch to 3.3V mode.

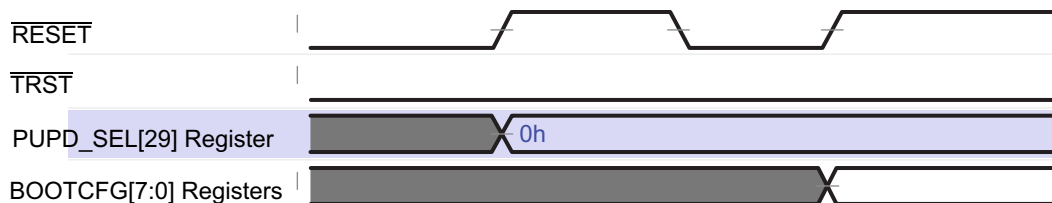
Figure 10. Initialization of PUPD_SEL[29] and BOOTCFG[7:0] Registers with Weak or No External Pull Resistors on BOOT[7:0] Pins

Internal pullups being enabled on the BOOT[7:0] pins may result in boot failures. If weak external pulldown resistors are used on the PCB to select the boot mode, they may not be able to overpower the internal pullups. This can result in the wrong boot mode being latched in the BOOTCFG[7:0] register when coming out of Reset.

Once the device is out of Reset, the PUPD_SEL[29] register is initialized, and the internal pulldown resistors for the BOOT[7:0] pins are all enabled. Issuing a second Power-On Reset ($\overline{\text{POR}}$) results in the intended boot mode being latched, since the pins are internally pulled down as expected.

Figure 10 shows the behavior of the PUPD_SEL[29] register before and after reset. Assuming weak or no external pull resistors are on the BOOT[7:0] pins, the BOOTCFG register will latch the unknown values after the device initially comes out of Reset. Note that, TRST **must** always be low in order to issue a POR and latch the boot pin values -- the boot pins are not latched after a Warm Reset.

Section 4, *Device Operating Conditions*, of the device datasheet shows the electrical characteristics information which can be used to calculate the maximum external pull resistance required. The value is dependent on the DVDD3318_C I/O supply level.

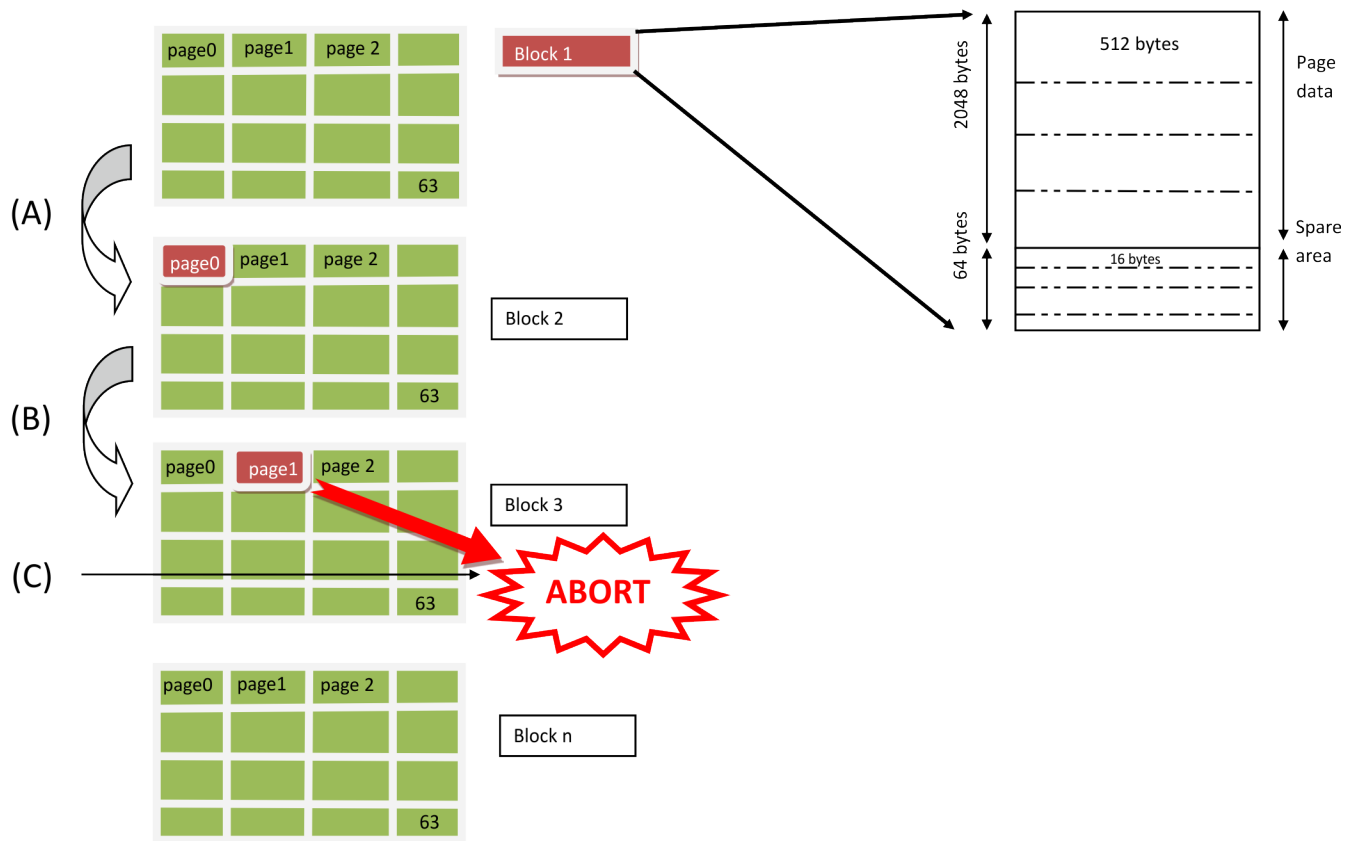
Figure 11. D800K008 ROM Behavior Before Application of Software Patch⁽¹⁾

However, over the life span of the NAND flash, ECC data stored in the spare area can develop errors due to bit flips. When the calculated syndrome indicates an error in the ECC data, the ECC Correct and Read functions of the RBL abort the read process even though, it is possible to correct up to 4 bit errors combined in user and ECC data. Consequently the device fails to boot.

If page0 of the good block has an ECC data error or an uncorrectable error (more than 4 bit errors combined), the RBL skips to the next block (shown as (B) in [Figure 11](#)). This bad block check mechanism enables the device to check up to the first 32 blocks in the NAND flash for booting (the boot process will fail if all 32 blocks have uncorrectable or ECC data errors in page0). Note that the RBL does not abort on detecting an error in ECC data on page0.

Once the RBL finds a good block with a good page0, it continues to read subsequent pages in that block. If an uncorrectable or ECC error is detected in subsequent pages, the RBL will abort with a boot error (shown as (C) in [Figure 11](#)). The workaround, described below, enables the boot process to continue for both types of errors (ECC data and uncorrectable errors).

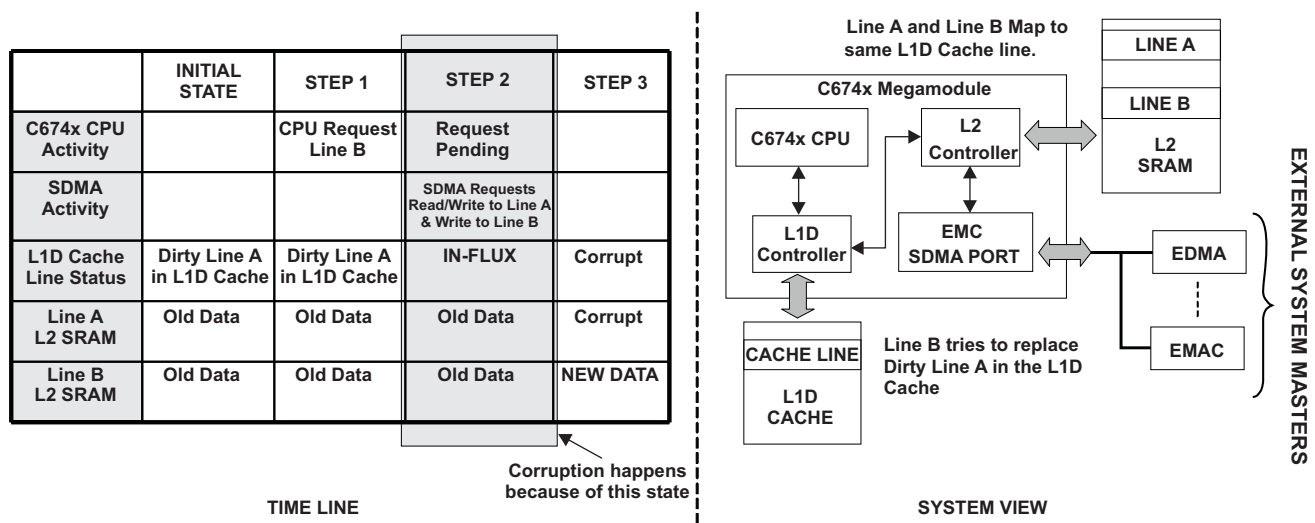
Figure 13. Example of L1D Cache and L2 RAM Corruption

1. L1D cache evicts a dirty line (Line A) while allocating a new line (Line B) in the same set/way (cache Lines A and B consist of 64-bytes each). In order for this to happen, the following will have taken place:
 - (a) Line A was previously read by CPU because L1D is a read-allocate cache,
 - (b) Line A is dirty because its value was modified by CPU, and
 - (c) Line B is read by CPU
2. Both Line A and Line B are associated with L2 RAM, and
3. While the original L1D victim write-back from condition (1) is in progress, the SDMA performs both:
 - (a) a read or write operation to Line A in L2 RAM and
 - (b) a write operation to Line B in L2 RAM.

If all of the above conditions are met, the L2 RAM data associated with the Line A victim writeback will become corrupt. Additionally, the Line B data originating from the SDMA write will also become corrupt in L1D cache. [Figure 13](#) shows an example scenario of L1D cache and L2 RAM corruption.

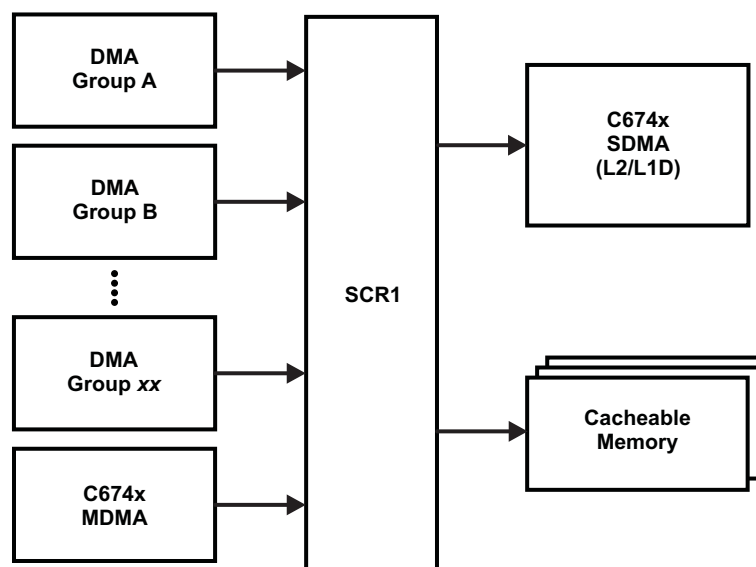
Figure 15. SCR1 System Interconnect

Step 2: The DSP's SDMA asserts itself as not ready and is unable to accept the write data from Step 1, and a cache line writeback is initiated from DSP memory to the same cacheable memory from Step 1. The cache line writeback command also passes through SCR1.

With the above scenario, it is possible for SCR1 to order the write commands from Step 1 in front of the write commands from Step 2. Due to the MDMA/SDMA blocking behavior, the SDMA commands from Step 2 will be waiting for the MDMA traffic from Step 1 to finish, resulting in a deadlock situation at SCR1. [Figure 15](#) is provided for illustrative purposes and is incomplete because of simplification.
