AM1808 ARM Microprocessor Silicon Revisions 2.1, 2.0, and 1.1

Silicon Errata

Literature Number: SPRZ313F
March 2010–Revised October 2013

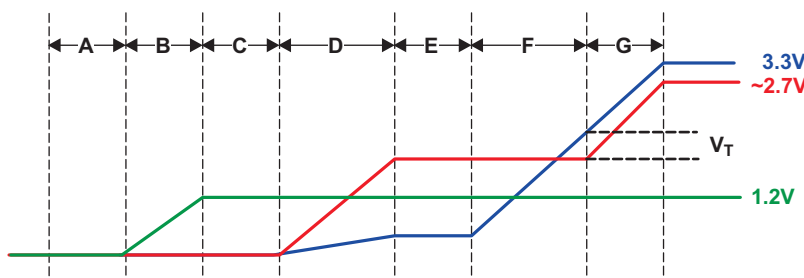
Figure 4. Faulty power-supply ramp

The behavior is the same until zone G. When the DVDD3318_x supply exceeds DVDD18 by a transistor V_T , the DVDD18 supply begins to be pulled up by the DVDD3318_x supply and follows the DVDD3318_x supply by DVDD3318_x - V_T . Since the DVDD18 supply is often connected to other 1.8V supplies in the design, these other supplies can be pulled up also.

The condition occurs because the dual-voltage IO buffers have voltage detection circuitry that monitors DVDD3318_x during reset and determines whether the applied supply voltage is 1.8V or 3.3V. This detection circuitry then configures the IOs to operate at the appropriate voltage. As the DVDD3318_x supply ramps, there is a small range near DVDD18 + V_T where the voltage detection circuit finds the state indeterminate and briefly turns on circuitry associated with both voltage options creating a current path between them. This current path can cause the DVDD18 supply to be pulled up. The mechanism for this behavior is explained below:

1. Design simulation has indicated that under the worst-case process/voltage/temperature conditions the maximum leakage current into the DVDD18 supply due to this phenomenon will be 140 mA (the 140 mA is a cumulative current generated by all of the dual-voltage IOs). So this error state can be prevented by ensuring that the load on the DVDD18 supply during the DVDD13318_x supply ramp exceeds 140 mA. This can be achieved by any combination of the following as long as they cumulatively produce >140 mA load on DVDD18 during the DVDD3318_x ramp period:

- (a) Maintain sufficient bulk capacitance on the DVDD18 supply such that the charging current for these capacitors provides all or part of the required >140 mA. Bulk capacitance in this context means the total capacitance seen by the DVDD18 supply (filter capacitors, bypass capacitors, etc.). Capacitor charging current is defined as $I = C \cdot (dV/dt)$. So the ramp rate of the DVDD3318_x supply and the total bulk capacitance on the DVDD18 supply can be used to calculate the current produced. This solution provides additional power supply filtering and little current leakage after the supplies are ramped (depending on the type of capacitors used).

2. Choose a regulator for the DVDD18 supply (or grouped 1.8V supplies) that is capable of actively regulating voltage up and down. Many high-efficiency switching regulators switch current into the load only when the voltage needs to be raised and rely on the load to pulldown the current. In this error condition, a regulator of this type will not be able to compensate for the leakage current described above. Synchronous buck regulators use external inductance to pulldown the regulated voltage when necessary.

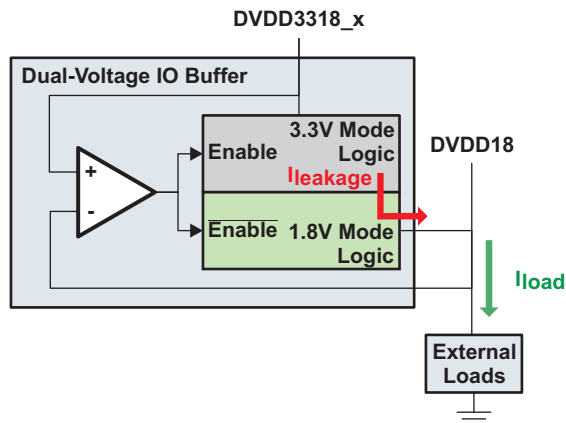
Figure 6. Error State of the IO buffer during Zone G

As DVDD3318_x exceeds DVDD18 + V_T , some of the circuitry across the boundary of the two voltage domains will turn on and causes a leakage current (in red) to flow between the two voltage domains. This current pulls up the DVDD18 supply unless the power source providing that supply can oppose it or unless the load current is strong enough to counteract it.

If DVDD18 continues to rise as DVDD3318_x ramps, the comparator never sees enough difference between the two supplies to switch to 3.3V mode.

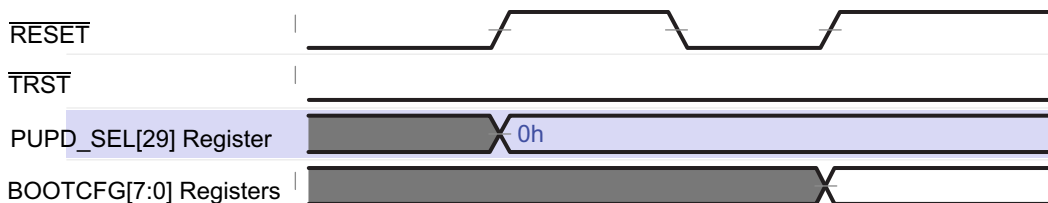
Figure 8. Initialization of PUPD_SEL[29] and BOOTCFG[7:0] Registers with Weak or No External Pull Resistors on BOOT[7:0] Pins

Internal pullups being enabled on the BOOT[7:0] pins may result in boot failures. If weak external pulldown resistors are used on the PCB to select the boot mode, they may not be able to overpower the internal pullups. This can result in the wrong boot mode being latched in the BOOTCFG[7:0] register when coming out of Reset.

Figure 8 shows the behavior of the PUPD_SEL[29] register before and after reset. Assuming weak or no external pull resistors are on the BOOT[7:0] pins, the BOOTCFG register will latch the unknown values after the device initially comes out of Reset. Note that, TRST **must** always be low in order to issue a POR and latch the boot pin values -- the boot pins are not latched after a Warm Reset.

Section 4, *Device Operating Conditions*, of the device datasheet shows the electrical characteristics information which can be used to calculate the maximum external pull resistance required. The value is dependent on the DVDD3318_C I/O supply level.

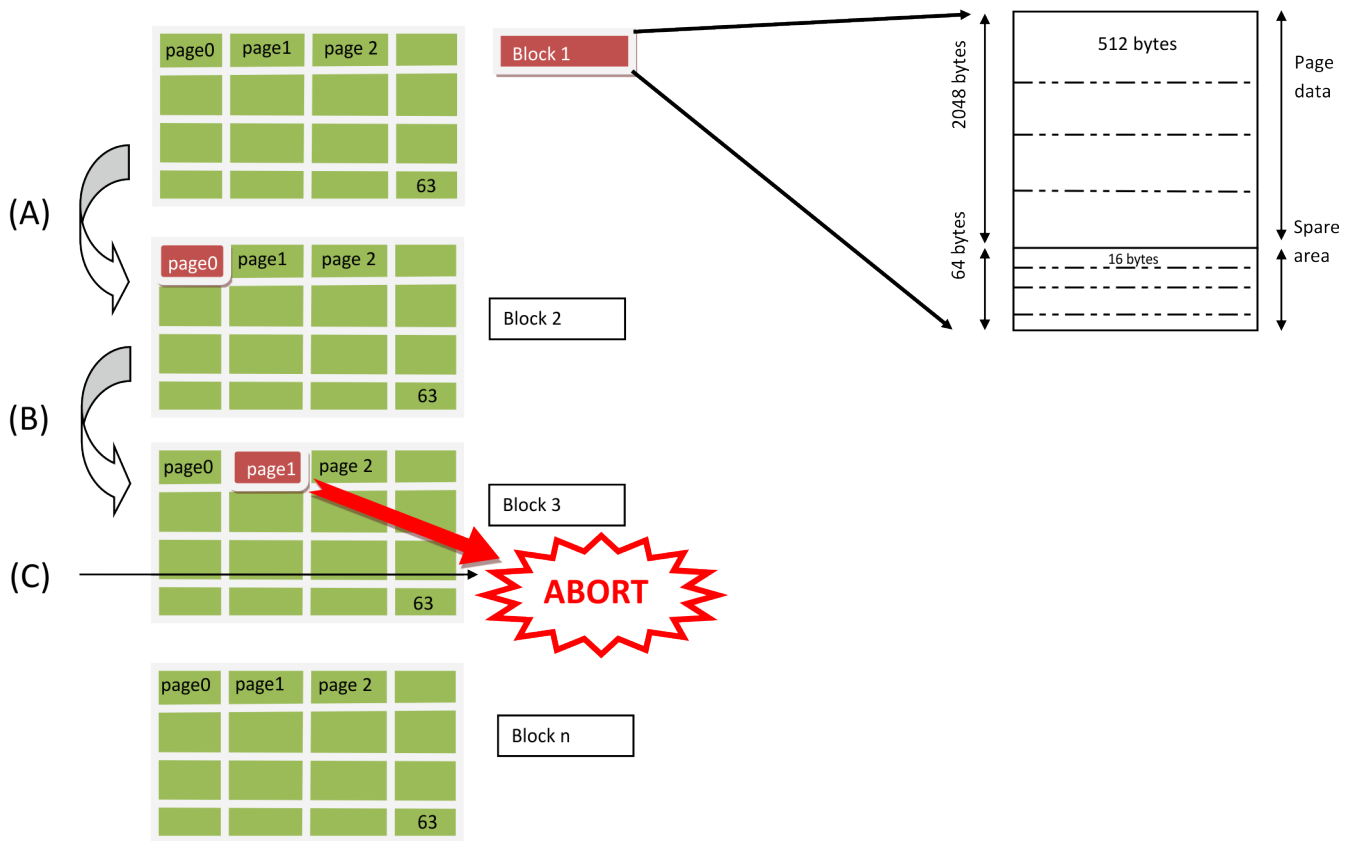
Figure 9. D800K008 ROM Behavior Before Application of Software Patch⁽¹⁾

However, over the life span of the NAND flash, ECC data stored in the spare area can develop errors due to bit flips. When the calculated syndrome indicates an error in the ECC data, the ECC Correct and Read functions of the RBL abort the read process even though, it is possible to correct up to 4 bit errors combined in user and ECC data. Consequently the device fails to boot.

If page0 of the good block has an ECC data error or an uncorrectable error (more than 4 bit errors combined), the RBL skips to the next block (shown as (B) in [Figure 9](#)). This bad block check mechanism enables the device to check up to the first 32 blocks in the NAND flash for booting (the boot process will fail if all 32 blocks have uncorrectable or ECC data errors in page0). Note that the RBL does not abort on detecting an error in ECC data on page0.

Once the RBL finds a good block with a good page0, it continues to read subsequent pages in that block. If an uncorrectable or ECC error is detected in subsequent pages, the RBL will abort with a boot error (shown as (C) in [Figure 9](#)). The workaround, described below, enables the boot process to continue for both types of errors (ECC data and uncorrectable errors).

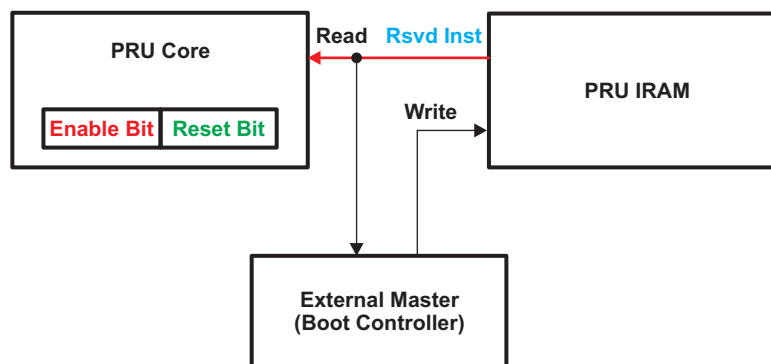
Figure 12. Boot Failure on Power-On

When the device is first powered-on, the read bus from the PRU IIRAM is not initialized and will contain random values (see Figure 12). Under unpredictable circumstances, the random value on the read bus may resemble a reserved instruction which can be interpreted by the PRU when the core is reset and not enabled.

If the PRU core executes this reserved instruction, it will not be able to properly execute the first functional op-code in the PRU IIRAM when the core is later enabled. In this fail state, the PRU will never acknowledge to the Boot Controller that the reset vector table was successfully initialized and the Boot Controller will be stuck in a polling loop waiting for the PRU to complete its task.
