TMS320DM816x DaVinci Video Processors

Revisions 2.1, 2.0, 1.1, 1.0

Silicon Errata

Literature Number: SPRZ329D
March 2011–Revised December 2012

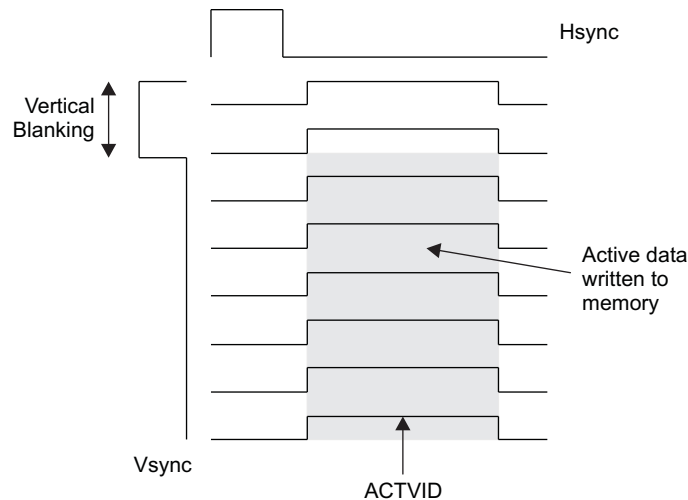
Figure 3. ACTVID Signal Active for All Lines of Incoming Data

Details: The VIP port supports a discrete sync capture mode where the ACTVID signal is used to determine the active region of the video and then the VPDMA writes this active video frame to memory. However, with some external video decoders, this mode does not work by default.

Workaround: The VIP parser requires that the ACTVID signal is active for all lines of the incoming data, including the vertical blanking region. The vertical blanking region, itself, is not written to memory by the VPDMA. [Figure 3](#) illustrates this.
