TMS320C6672

Multicore Fixed and Floating-Point Digital Signal Processor

Silicon Revision 1.0, 2.0

Silicon Errata

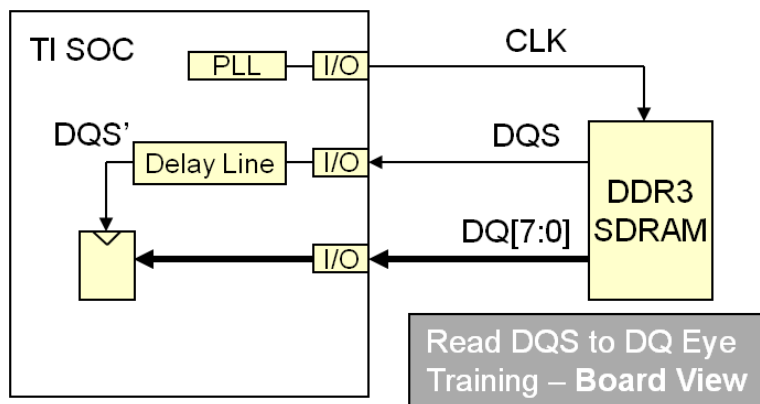
Figure 2 Read DQS to DQ Eye Training - Board View

The intended purpose of the Read Data Eye Training feature is to align the DQS sampling transitions in the middle of the DQ data eye within individual byte lanes of the DDR3 memory interface. As seen in [Figure 2](#), the DQS signal can be delayed relative to the DQ signal within the DDR3 PHY.

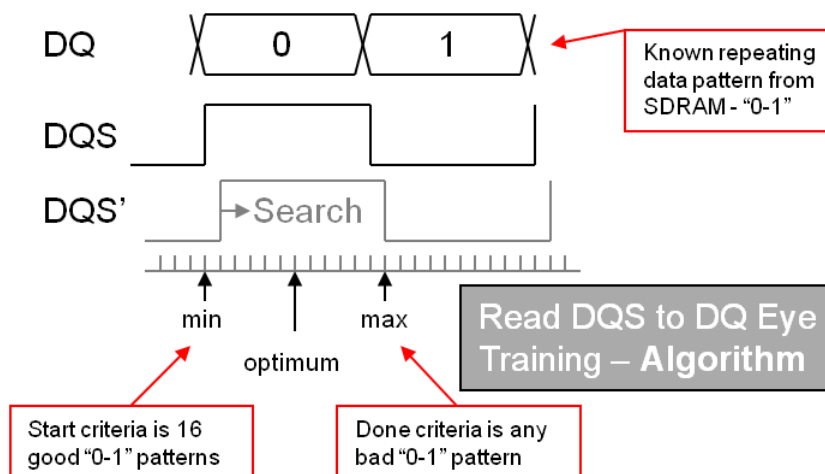
Figure 3 Read DQS to DQ Eye Training - Algorithm

As shown in Figure 3, the Read Data Eye Training algorithm should correctly detect the extents of the DQ data eye. The SDRAM are put into a DQS to DQ eye training mode and read back an alternating 0, 1 pattern.

The DDR3 PHY uses this pattern to detect good or bad data being sampled by the DQS transitions. The DDR3 PHY searches by delaying DQS relative to DQ until these constraints are found.

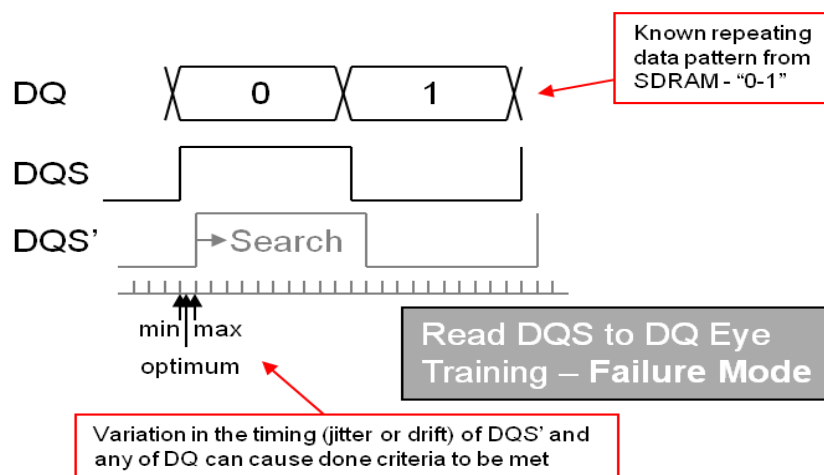
Figure 4 Read DQS to DQ Eye Training - Failure Mode

The leveling feature with the problem is the Read Data Eye Training. Depending on the jitter seen on the DQ and DQS signals, this leveling feature will fail to converge on a good data eye, resulting in corrupted DSP to DDR3 SDRAM reads.

However, if too much jitter is present on the DQ or DQS signals, the search can converge to a false edge as shown in Figure 4.

Workaround 1:

The DDR3 PHY in the device has the ability to complete auto-leveling of the write leveling values and the read DQS gate training values separate from the read data eye training. Then a fixed value is used as the read data eye sample point. This solution is functional on standard DDR3 fly-by layouts and is referred to as Partial Automatic Leveling. It has been validated for robust operation at DDR3-1333 when connected to either a UDIMM or with a discrete SDRAM implementation.

This mode is enabled by setting bit 9 (0-indexed) of the DDR3_CONFIG_REG_23 at address 0x02620460. The lower 8 bits (bits 7:0) may be written with a read data eye sample value or left at their default value of 0x34. The default value is recommended for use. After programming DDR3_CONFIG_REG_23, proceed to enable auto-leveling. Please refer to the *DDR3 Initialization Application Report* (literature number [SPRABL2](#)) for details of the sequence of steps.

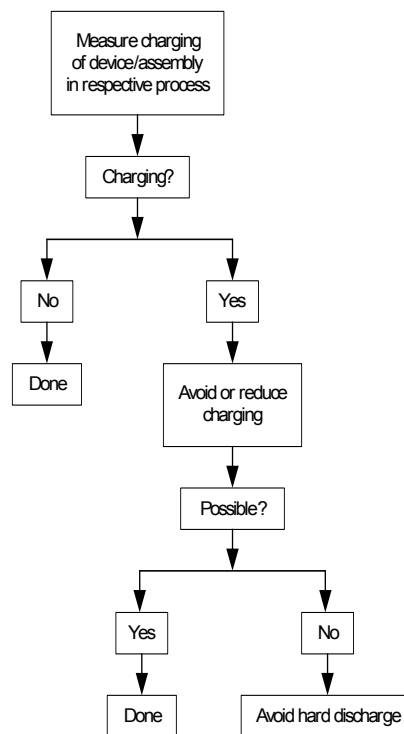
Figure 6 The Basic Flow to Analyzing the Risk

Details: All data manual specifications associated with the SerDes high-speed functional pins are guaranteed to a maximum component Electrostatic Discharge - Charged Device Model (ESD-CDM) pulse threshold of 150V.

Due to the sensitive nature of the SerDes high-speed pins, exceeding component ESD CDM stress pulses of 150V on the functional pins listed below may cause permanent changes to the output swing and the de-emphasis behavior associated with these pins.

Workaround: While there is no strict workaround for this issue, there are several ways to analyze the risk with regards to CDM. [Figure 6](#) shows the basic flow for analyzing this risk:

Using generally accepted *good practices* during the assembly process can help to minimize the likelihood of a hard discharge. These practices include:

- The use of an ionizer near the PCB before, during, and after placement of parts
- The use of grounded, conductive/dissipative suction cups when using pick-and-place machines
- The use of dissipative materials for downholder pins and/or plastic covers as well as two-stage pogo-pins while performing in-circuit-test

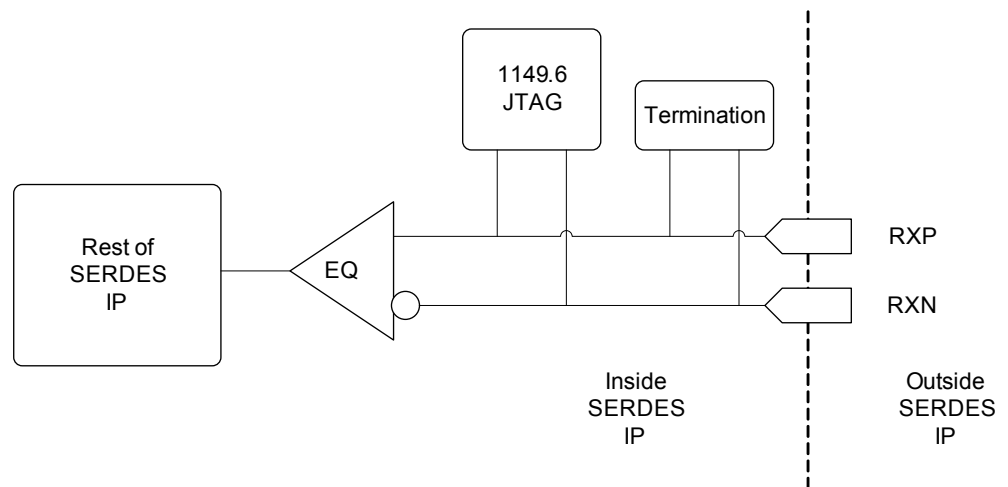
Figure 7 Simplified SerDes Receiver Block Diagram Depicting Relative Placement of Major Receiver Components

A problem has been identified in some cases where the AC-JTAG (IEEE 1149.6, edge-sensitive) input cells on Rincewind and Draco receivers do not reliably respond to input edge transitions from an associated transmitter. Because of this failure, the 1149.6 scan-chain users can receive faulty signal levels transitions or no transitions at all.

IEEE 1149.1, level-sensitive, input cells show no issue and normal operation of the SerDes receivers is also unaffected by this problem.

The reason for the issue is due to the original AC-JTAG input cell performance being overly sensitive to rise/fall times of the signals interfacing to it and input transition frequency.

Workaround: One potential workaround has been identified. The failure mode of the AC-JTAG comparator is most pronounced by single edge transitions at low frequency as this creates the highest likelihood of the comparator inputs being saturated and switching incorrectly. More frequent transitions can result in proper switching of the comparator output.

The basic procedure is to initiate multiple edge transitions and then read the state of the RX input cell in question. However, due to the nature of the failure, the exact number would have to be determined experimentally for a given device.
