TMS320C6671

Multicore Fixed and Floating-Point Digital Signal Processor

Silicon Errata

Literature Number: SPRZ366F
May 2013

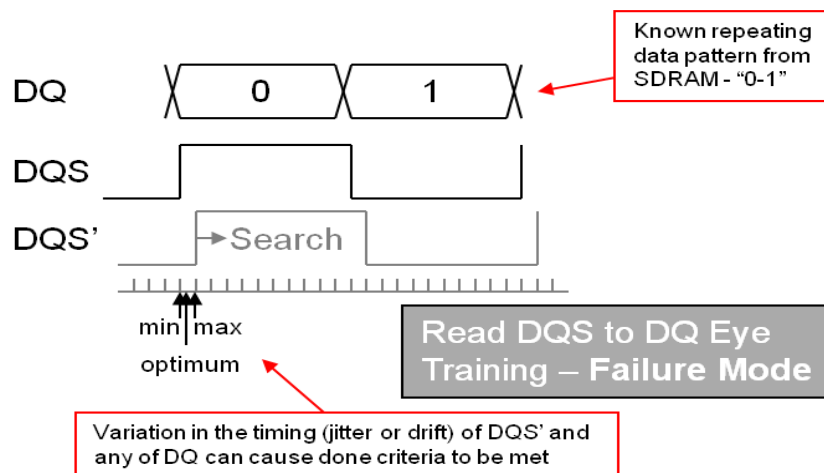
Figure 4 Read DQS to DQ Eye Training - Failure Mode

The leveling feature with the problem is the Read Data Eye Training. Depending on the jitter seen on the DQ and DQS signals, this leveling feature will fail to converge on a good data eye, resulting in corrupted DSP to DDR3 SDRAM reads.

However, if too much jitter is present on the DQ or DQS signals, the search can converge to a false edge as shown in Figure 4.

Workaround 1:

The DDR3 PHY in the device has the ability to complete auto-leveling of the write leveling values and the read DQS gate training values separate from the read data eye training. Then a fixed value is used as the read data eye sample point. This solution is functional on standard DDR3 fly-by layouts and is referred to as Partial Automatic Leveling. It has been validated for robust operation at DDR3-1333 when connected to either a UDIMM or with a discrete SDRAM implementation.

This mode is enabled by setting bit 9 (0-indexed) of the DDR3_CONFIG_REG_23 at address 0x02620460. The lower 8 bits (bits 7:0) may be written with a read data eye sample value or left at their default value of 0x34. The default value is recommended for use. After programming DDR3_CONFIG_REG_23, proceed to enable auto-leveling. Please refer to the *DDR3 Initialization Application Report* (literature number [SPRABL2](#)) for details of the sequence of steps.

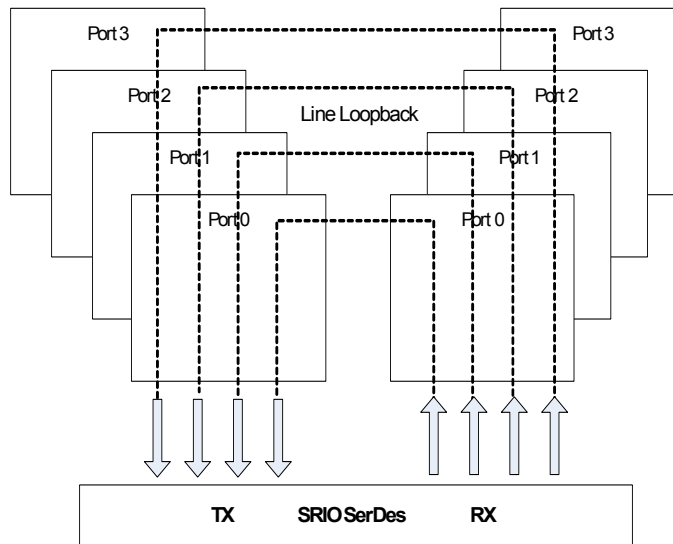
Figure 5 SRIO SerDes in Loopback Mode

Details: The SRIO physical layer is configured in line loopback mode on a per-port basis, by setting the LLB_EN bit in PLM_SP(n)_IMP_SPEC_CTL register. In line-loopback mode, the data from the SerDes receiver is looped back to the SerDes transmitter. [Figure 5](#) shows the line loopback from SerDes RX to SerDes TX:

The port does not provide any clock compensation when line loopback is enabled. The transmit clock must be externally synchronized with the receive clock. There is only a small FIFO that can compensate for PLL jitter or wander. Hence, correct operation of line loopback requires that the link partners use the same reference clock for the SRIO physical layer, in order to avoid overruns or underruns due to clock frequency mismatch between the link partners. As a result, line loopback mode is generally restricted to validation and qualification of board signal integrity in a lab environment.

When line loopback is enabled on one or more SRIO ports, any valid 10b code group that decodes to an illegal control character as defined by the RapidIO Specification (Revision 2.1) and whose most significant bit is 0, will be corrupted on transmission.

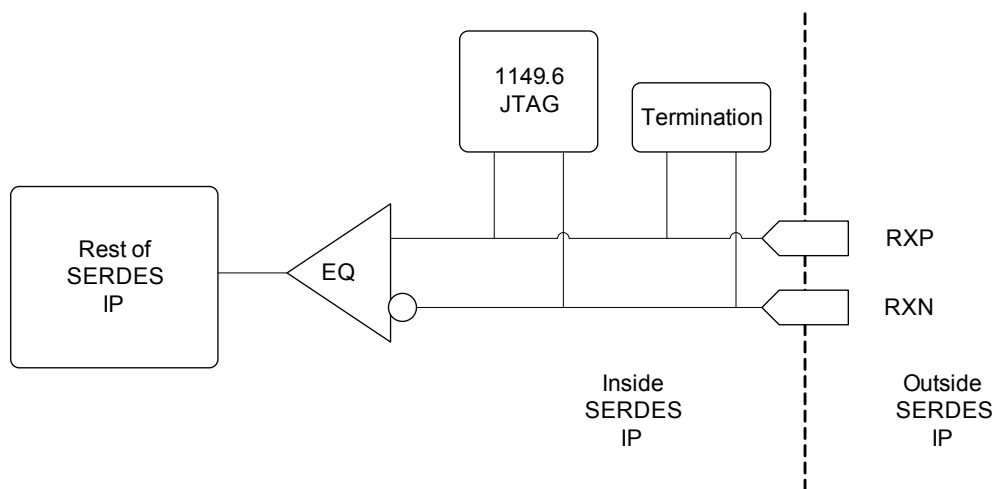
Figure 7 Simplified SerDes Receiver Block Diagram Depicting Relative Placement of Major Receiver Components

A problem has been identified in some cases where the AC-JTAG (IEEE 1149.6, edge-sensitive) input cells on Rincewind and Draco receivers do not reliably respond to input edge transitions from an associated transmitter. Because of this failure, the 1149.6 scan-chain users can receive faulty signal levels transitions or no transitions at all.

The reason for the issue is due to the original AC-JTAG input cell performance being overly sensitive to rise/fall times of the signals interfacing to it and input transition frequency.

Workaround: One potential workaround has been identified. The failure mode of the AC-JTAG comparator is most pronounced by single edge transitions at low frequency as this creates the highest likelihood of the comparator inputs being saturated and switching incorrectly. More frequent transitions can result in proper switching of the comparator output.

The basic procedure is to initiate multiple edge transitions and then read the state of the RX input cell in question. However, due to the nature of the failure, the exact number would have to be determined experimentally for a given device.

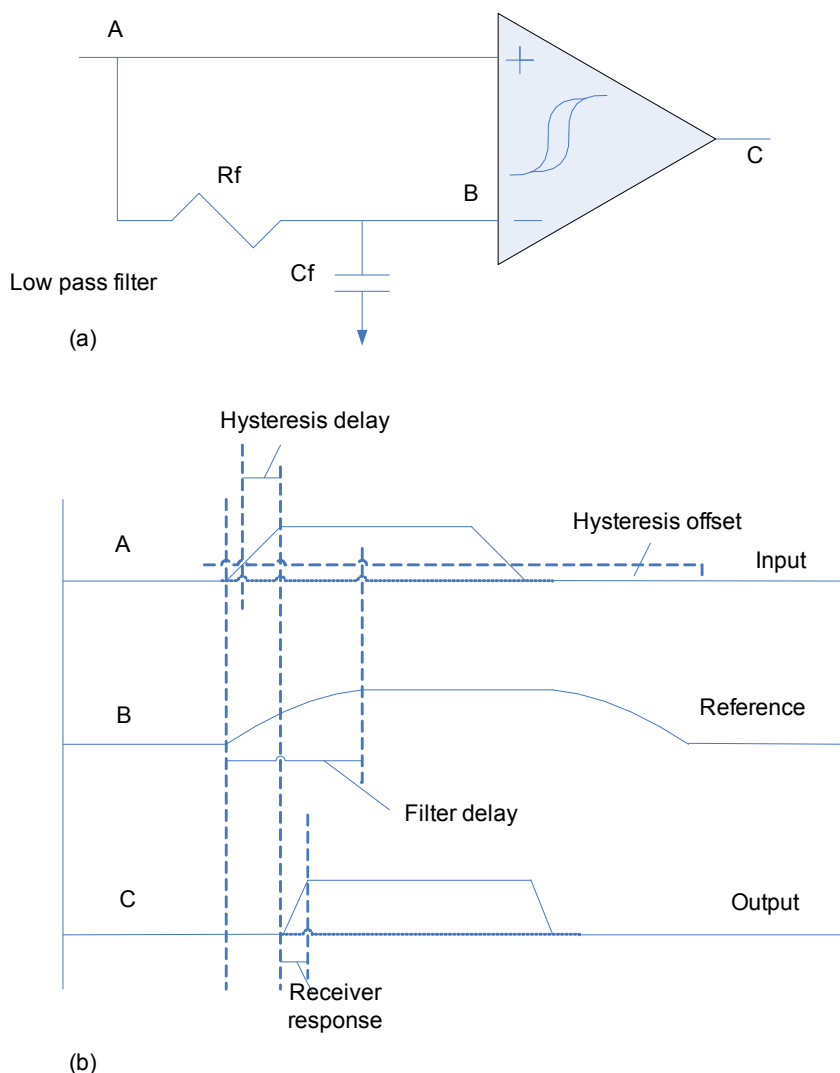
Figure 8 Self-referenced Comparator and Response (See Note Below)

When the comparator inputs are saturated the comparator gain is minimized and under certain PVT conditions (strong silicon, 125C junction temperature, minimum VDDT), the comparator can fail to switch to the proper state, or not respond at all.

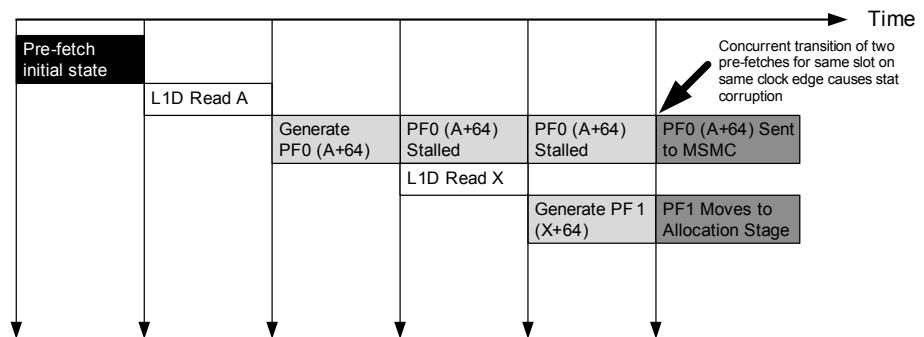
Figure 11 Sequence diagram

The fault lies in the 'sorting' hardware which can lead to the first pre-fetch not being marked stale under certain boundary conditions (see pathological sequence below). The subsequent fetch access when the pre-fetch access wasn't marked stale will access the stale data that has been cleared (but not yet marked as stale.) This results in the read exception and/or incorrect data being fetched. Thus, the issue occurs only when the re-fetch feature is triggered and only L1D accesses use the re-fetch feature.

3. Data pre-fetcher re-fetch behavior is triggered which generates pre-fetch (PF0) to A+64.
4. PF0 stalls in XMC pipeline until step 7
5. L1D pre-fetchable data read to address X hits in candidate or pre-fetch buffer, triggering allocation of entry [0] to stream starting at X+64
6. A pre-fetch for address X+64 (PF1) is generated for entry [0] early half and followed in a subsequent cycle by X+128 (PF2).
 - a. Either PF1 or PF2 can map to the same buffer slot as PF0 (this example maps PF1)
7. PF0 transitions to the XMC output (to MSMC) on the exact same clock edge that PF1 is transitioning to the buffer allocation pipeline stage

8. Instead of PF0 being marked stale and thrown away when returned, both PF0 and PF1 are marked valid and outstanding.
9. This leads to two valid outstanding pre-fetches for the same data buffer slot which is an invalid state and can result in unexpected behavior for a subsequent pre-fetchable data access to address X+64.
