## **3 Volt Intel StrataFlash<sup>®</sup> Memory** 28F128J3A, 28F640J3A, 28F320J3A

**Specification Update**

April 2002

**Notice:** The 28F128J3A, 28F640J3A, and 28F320J3A may contain design defects or errors known as errata that may cause the product to deviate from published specifications. Current characterized errata are documented in this specification update.

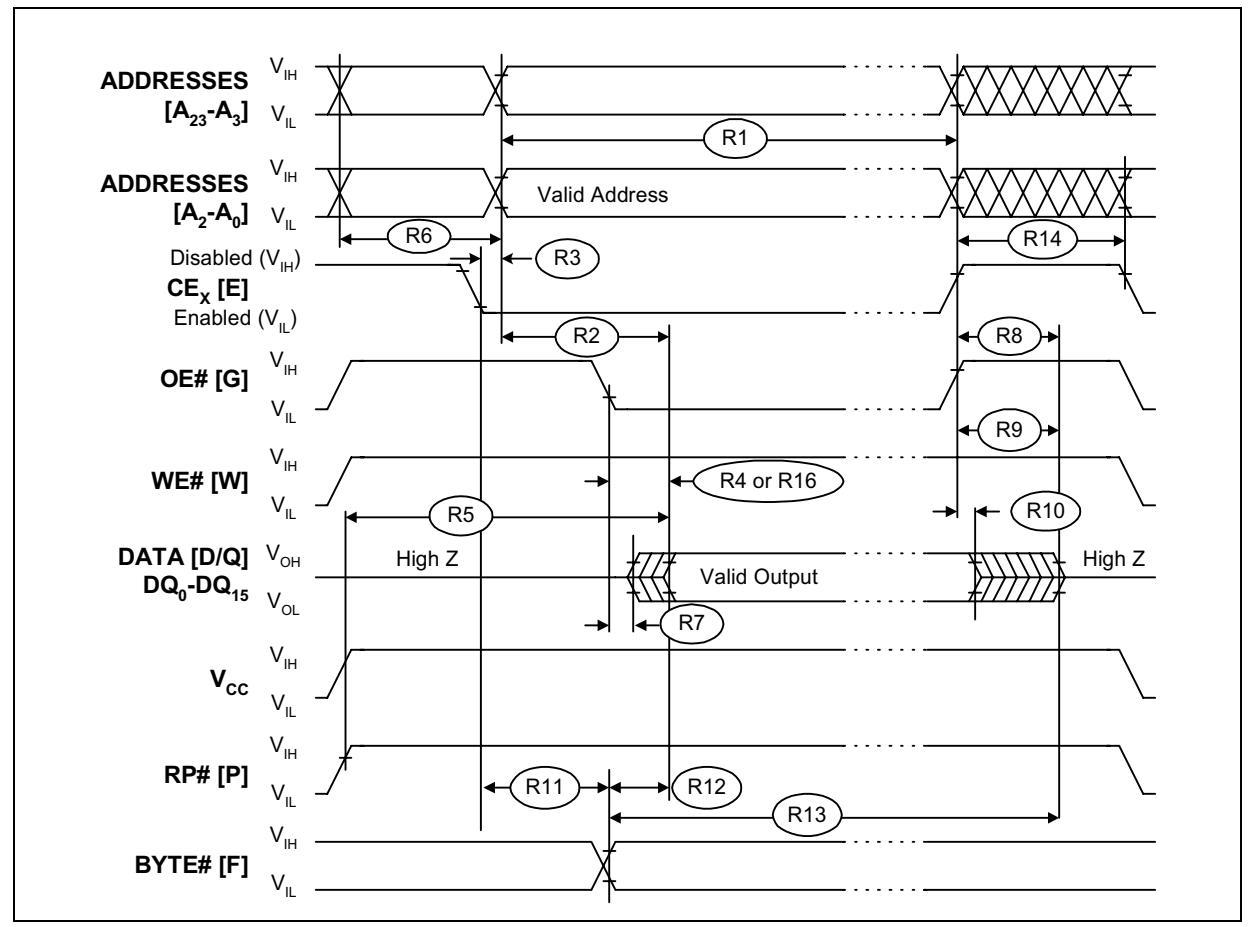
### Figure 1. AC Waveform for Standard Word/Byte Read Operations

6.	Read Parameter t <sub>ELQX</sub>
Problem:	Devices need the parameter $t_{ELQX}$ =150 ns minimum. CE low to output in low Z ( $t_{ELQX}$ ) is designated as R6 in Figure 1, in this Specification Update revision.
Implication:	Higher volume prototype testing could experience read failures if this erratum is ignored.
Workaround:	Use devices for initial lower volume prototype development.
Status:	This is intended to be fixed in future steppings. Refer to the <i>Summary Tables of Changes</i> to determine affected product(s) and stepping(s). This is fixed on A3 and above steppings.

7.	Read Parameter t <sub>ELAV</sub>
Problem:	Devices need the parameter $t_{ELAV} = 500$ ns maximum. Chip Enable to Address Valid ( $t_{ELAV}$ ) is designated as R3 in Figure 1, in this Specification Update revision.
Implication:	Higher volume prototype testing could experience read failures if this erratum is ignored.
Workaround:	Use devices for initial lower volume prototype development.
Status:	This is intended to be fixed in future steppings. Refer to the <i>Summary Tables of Changes</i> to determine affected product(s) and stepping(s). This is fixed on A3 and above steppings.
