PIC16F88X Family Silicon Errata and Data Sheet Clarification

The PIC16F88X family devices that you have received conform functionally to the current Device Data Sheet (DS41291G), except for the anomalies described in this document.

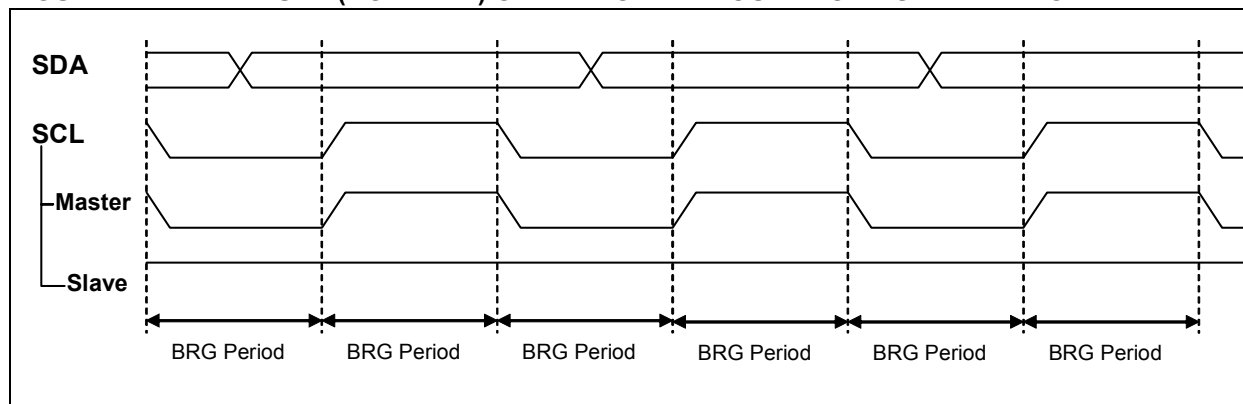
FIGURE 1: ACTUAL (CORRECT) OPERATION WITHOUT CLOCK STRETCHING

Figure 1 illustrates an expected I²C transmission in which the SCL line is completely controlled by the master device and the slave device does not attempt to stretch the clock period.

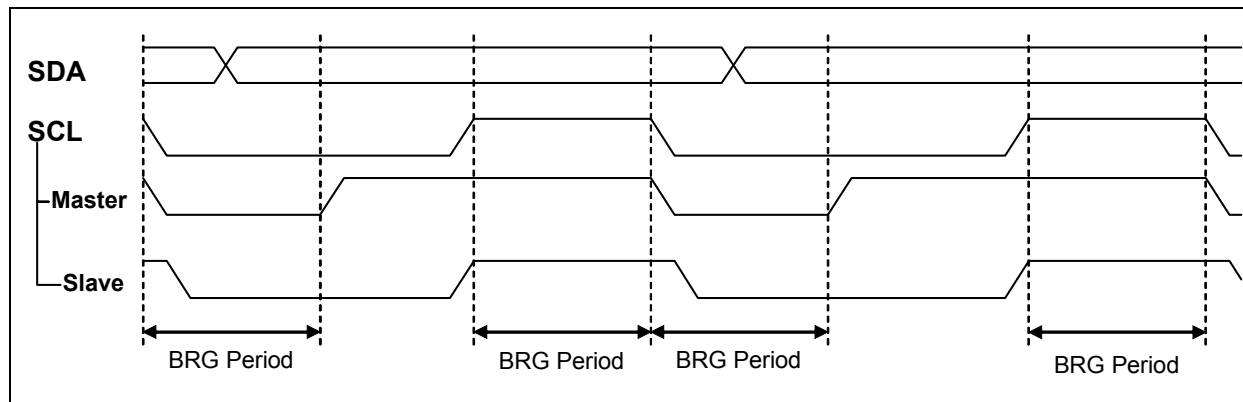
FIGURE 2: EXPECTED OPERATION WITH CLOCK STRETCHING

Figure 2 illustrates the expected operation of an I²C transmission in which the slave device has stretched the clock period by holding the SCL line low. The high time of the SCL pulse is constant, regardless of the duration of the clock stretch.
