TMS320C6748 Fixed/Floating-Point DSP Silicon Revisions 2.1, 2.0, 1.1 and 1.0

Silicon Errata

Literature Number: SPRZ303G
June 2009–Revised October 2013

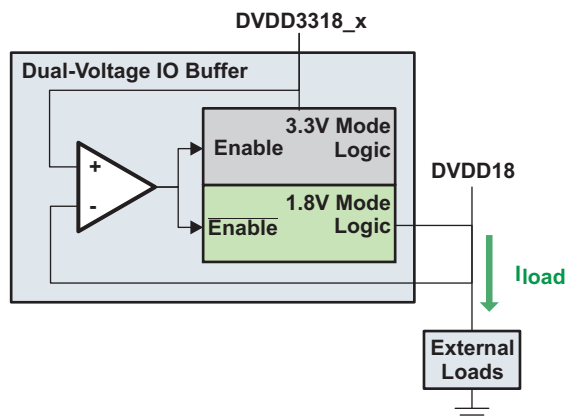
Behavior of the IO buffer during Zone F:

As the DVDD3318_x supply ramps, but is not yet one V_T above the DVDD18 supply, the comparator enables the 1.8V mode logic section and disables the 3.3V mode logic section. No unexpected current flows between the two sections.

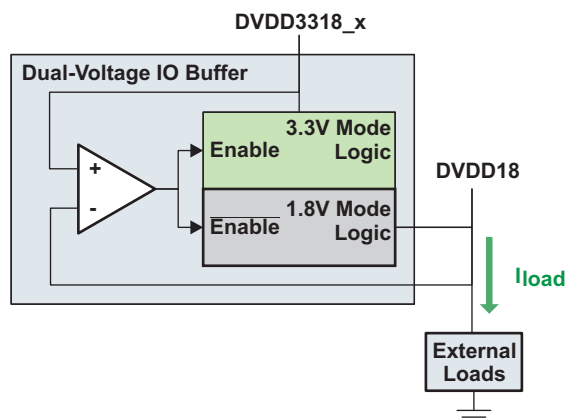
Recovered State of the IO buffer during Zone G:

If the load current is high enough or the DVDD18 power supply can oppose the leakage current, then the DVDD18 voltage stays low enough for:

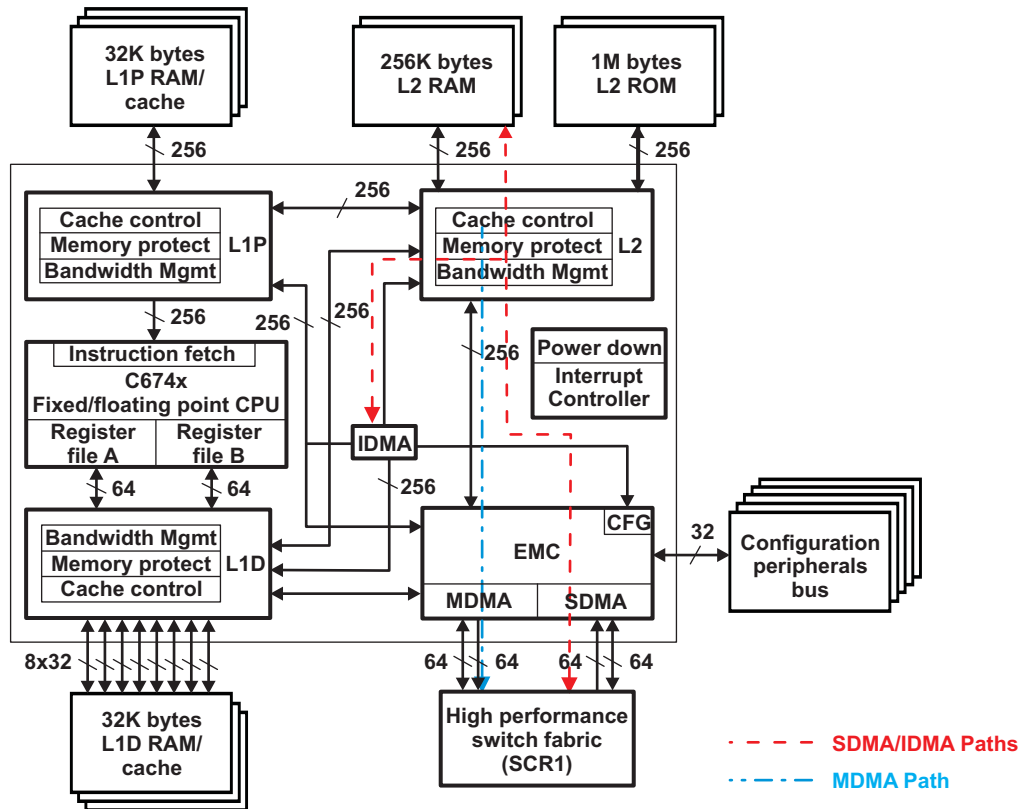
Figure 14. C674x Megamodule

Ideally, the MDMA (dashed-dotted line in Figure 14) and SDMA/IDMA paths (dashed lines in Figure 14) operate independently with minimal interference. Normally MDMA accesses may stall for extended periods of time due to expected system level delays (for example, bandwidth limitations). However, when using L2 as RAM, SDMA and IDMA accesses to L2/L1 may experience unexpected stalling in addition to the normal stalls seen by the MDMA interface. For latency-sensitive traffic, the SDMA stall can result in missing real-time deadlines. In a more severe case, the SDMA stall can produce a deadlock condition in the device. An IDMA stall cannot produce a deadlock condition.

Note: SDMA/IDMA accesses to L1P/D will not experience an unexpected stall if there are no SDMA/IDMA accesses to L2. Unexpected SDMA/IDMA stalls to L1 happen only when they are pipelined behind L2 accesses. Additionally, the deadlock scenario will be avoided if there are no SDMA accesses to L2.

The duration of the SDMA/IDMA stalls depend on the quantity/characteristics of the L1/L2 cache and the MDMA traffic in the system. Therefore, it is difficult to predict if stalling will occur and for how long.
