AM1808 ARM Microprocessor Silicon Revisions 2.1, 2.0, and 1.1

Silicon Errata

Literature Number: SPRZ313F
March 2010–Revised October 2013

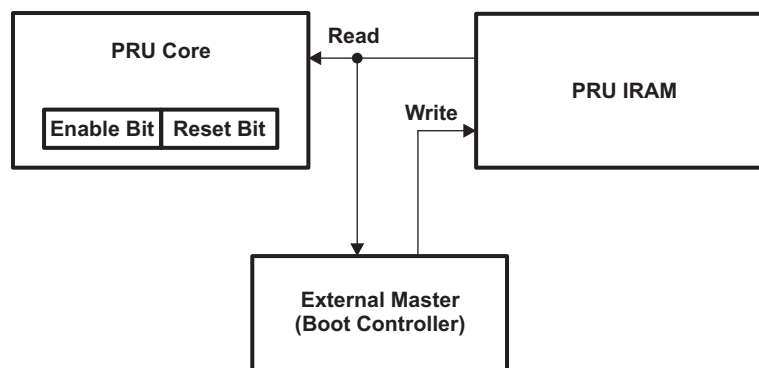
Figure 11. PRU and Boot Controller Block Diagram

The ARM reset vector table is located in the ARM's local RAM, however the ARM local RAM can only be accessed by two bus masters: ARM and PRU0. Therefore, the Boot Controller must program PRU0 to copy the desired reset vector table into the ARM's local RAM.

The PRU instructions are located inside of an instruction RAM (IRAM) which is initialized by the Boot Controller (see Figure 11). After the instructions are stored to IRAM, the PRU is reset and enabled to execute its instructions. In this case, the PRU is instructed to initialize the ARM reset vector table.

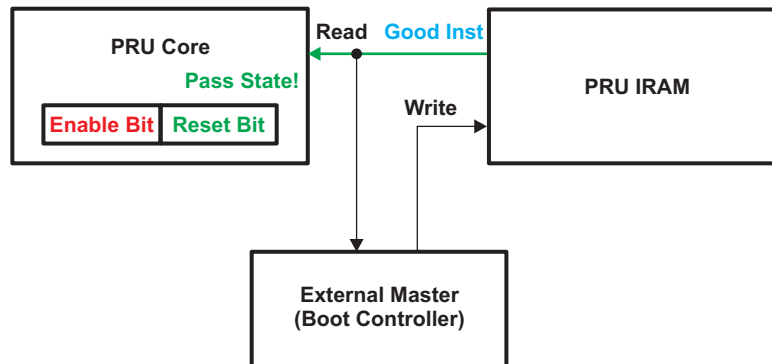
Figure 13. Secondary Reset

Although the PRU core execution is stuck, the PRU IRAM read bus is now initialized with a non-reserved instruction that was fetched from the IRAM by the PRU core (see [Figure 13](#)). If a secondary reset is provided to the device (either POR or WARM), the PRU will be able to execute its functional instructions as expected.

Note that in order to recover from this fail state with a secondary reset, the Boot Controller must be allowed to execute up to the point where the PRU has fetched a known instruction from the PRU IRAM. The approximate count of 15k clock cycles is sufficient.

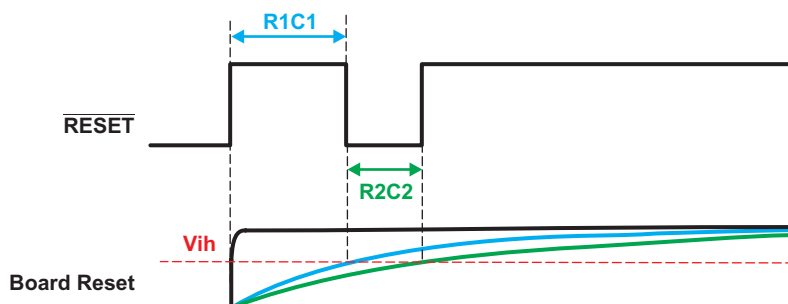
Figure 17. RESET Signal vs Board Reset

[Figure 17](#) shows the relationship between the board reset signal and the RESET signal produced by the circuit. The blue and green lines represent the voltage as seen by the Schmitt buffers. The output voltage of a charging RC circuit is defined as: $V_o = V_i * (1 - e^{-t / RC})$

Given ideal conditions, a 3.3V board reset signal, and an input buffer V_{ih} of 1.4V, the following set of component values would generate an initial RESET high period (R1C1 region) of approximately 2ms and a RESET low period (R2C2 region) of approximately 0.5ms:
