LXT9761/62/63/81/82 PHY Transceivers

Specification Update

March 2001

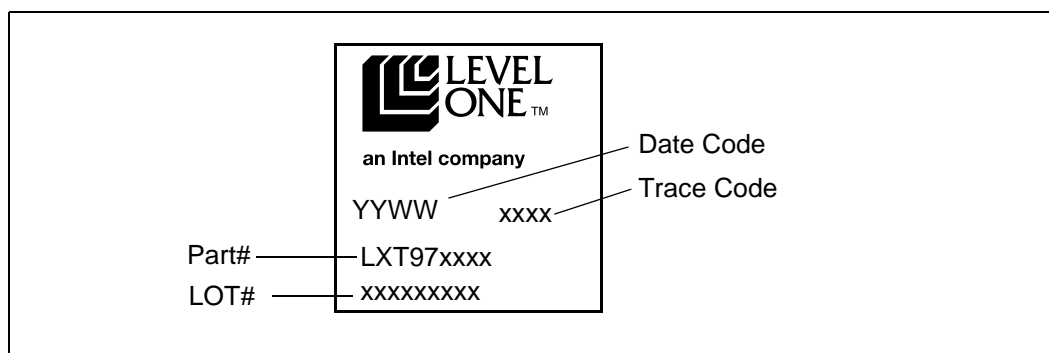
Markings

The silicon stepping in the LXT97xx Data Sheets is referred to as “Manufacturer’s Revision Number.” The silicon stepping number may be read by software from Register 3, bits 3:0 in the LXT97xx transceivers.

Stepping	Revision Number ¹	Trace Codes ²	Manufacturer’s Revision Number ³	Notes
6	A9, B2, C3	Hx9x, WxKx, 4xTx	0110	
7	A11, C4	Hx2x, 4xUx	0111	
1. Revision numbers listed on the same line are the same product stepping, but are produced at different fabrication facilities. 2. x indicates an insignificant variable. 3. This value is from register bits 3.3:0. Please see the LXT97xx data sheets for more information.
