*TMS570LS31x/21x Microcontroller*

**Silicon Revision B**

# Silicon Errata

Literature Number: SPNZ193D  
November 2012–Revised October 2013

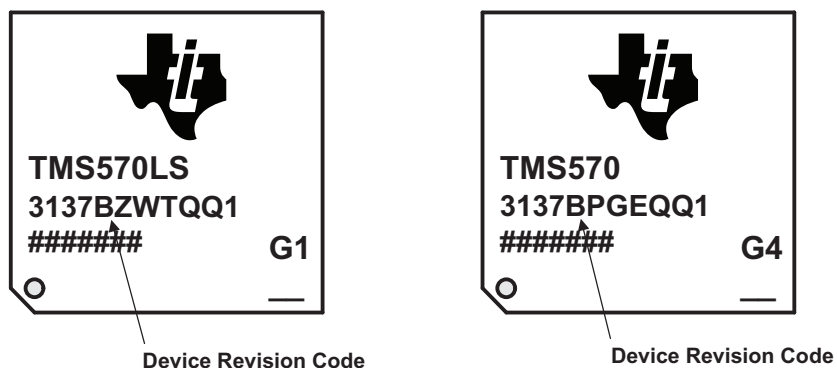
**Figure 1. Device Revision Code Identification**

**Figure 1** provides examples of the TMS570LSx device markings. The device revision can be determined by the symbols marked on the top of the device.
