**TMS320F28069, TMS320F28068,  
TMS320F28067, TMS320F28066,  
TMS320F28065, TMS320F28064,  
TMS320F28063, TMS320F28062 Piccolo MCU**

## **Silicon Errata**

Literature Number: SPRZ342G  
January 2011–Revised August 2013

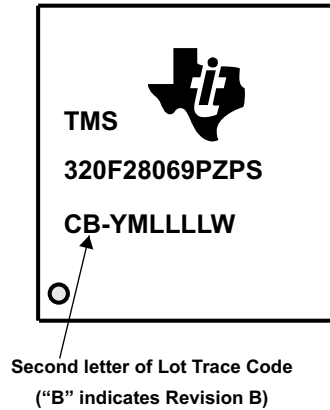
**Figure 1. Example of Device Markings**

**Figure 1** provides an example of the 2806x device markings and defines each of the markings. The device revision can be determined by the symbols marked on the top of the package as shown in **Figure 1**. Some prototype devices may have markings different from those illustrated. **Figure 2** shows an example of the device nomenclature.

**Table 1. Determining Silicon Revision From Lot Trace Code**

SECOND LETTER IN PREFIX OF LOT TRACE CODE	SILICON REVISION	REVISION ID (0x0883)	COMMENTS
Blank (no second letter in prefix)	Indicates Revision 0	0x0000	This silicon revision is available as TMX.
A	Indicates Revision A	0x0001	This silicon revision is available as TMS.
B	Indicates Revision B	0x0002	This silicon revision is available as TMS.

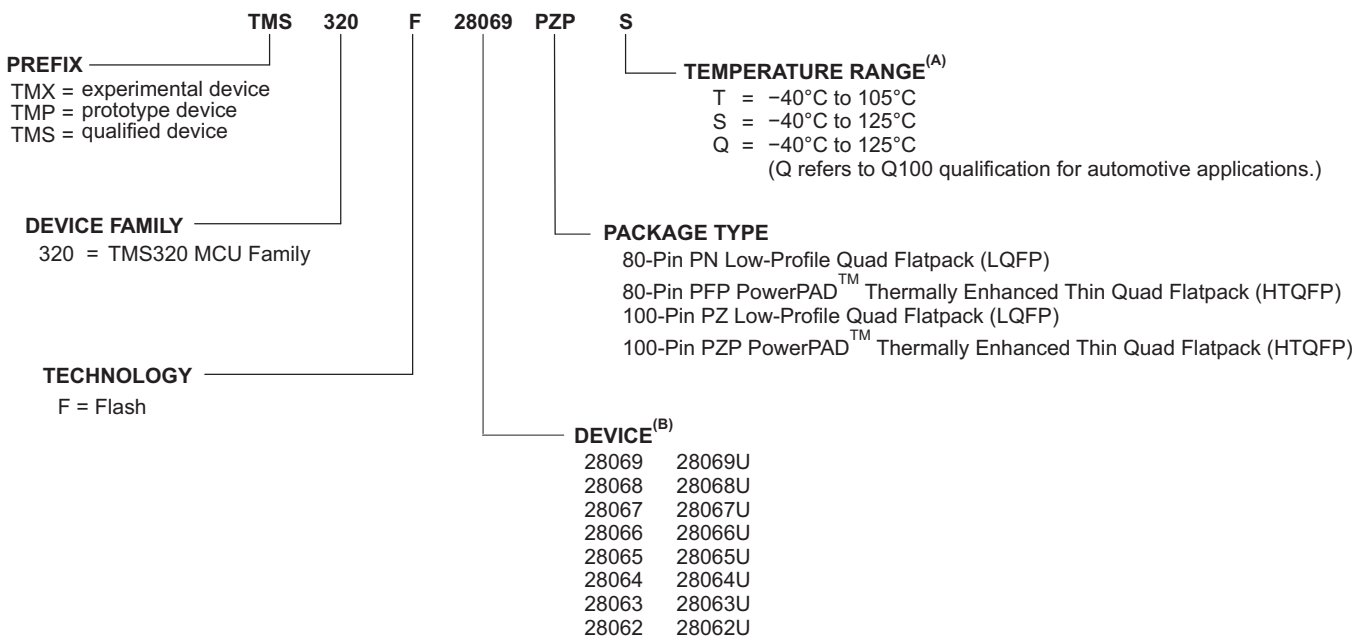
**Figure 2. Example of Device Nomenclature**

A The "Q" temperature option is **not** available on the 2806xU devices.

B USB is available only on 2806xU devices.
